Local Development Framework
Evidence Base

Foulness Churchend
Conservation Area Appraisal and
Management Plan

LDF Evidence
Base

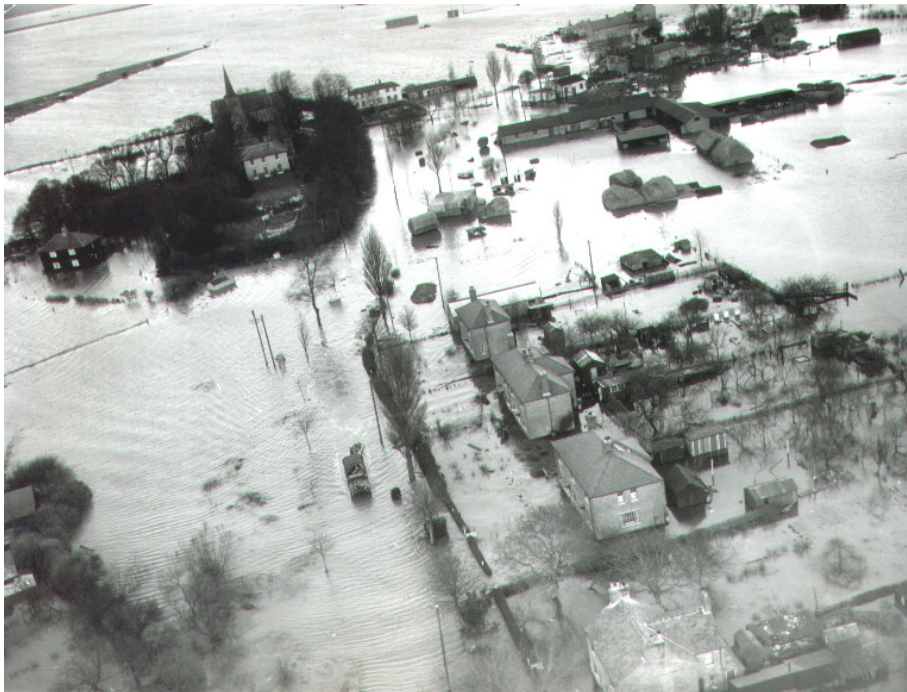
- 6.10 Despite the preventive measures taken to protect the island from the sea over the centuries, Foulness still experienced inundations, the worst of which occurred on the night of 31st January 1953 when severe gale-force northerly winds coinciding with a spring tide resulted in the greatest surge ever recorded (*Fig. 7*). Although the War Department had increased the height of the sea walls, the huge waves whipped up by the wind swept over them, inundating the island. Foulness was left completely cut off from the mainland with neighbouring islands submerged, and telephone, gas and electricity lines broken. Two people died, and 335 were eventually evacuated. In addition, a remarkable rescue operation was carried out under appalling conditions to save hundreds of stricken livestock. The tally of animals eventually evacuated included 400 cattle, 72 sheep, 670 chickens and four budgerigars¹¹. The land eventually recovered from the ill-effects of salt water saturation, and a tree-planting scheme was introduced to replace trees swept away by the flood waters.

*Fig. 7 Churchend after the 1953 flood looking north. The church and rectory are marooned in the top left, with Old Hall Farm opposite, its haystacks swept aside by the flood waters. Nos 15-18 Churchend are to the south.
Reproduced with kind permission of R.W. Crump*

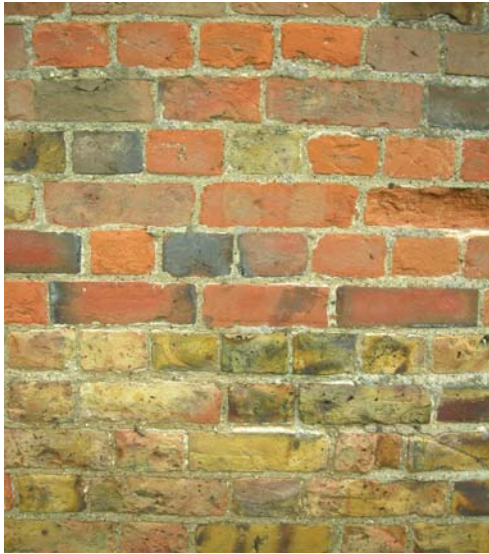
- 7.11 The conservation area exhibits a varied but limited range of materials that are an important characteristic of local distinctiveness. Brick is much in evidence, principally yellow stock brick from the Shoeburyness brick fields used from the mid-19th century and laid in Flemish bond or stretcher bond (although an older farm building displays areas of English bond). Occasionally earlier soft red bricks can be seen (*Fig. 18*). Weatherboard is the other dominant exterior wall treatment, and is generally painted white on front elevations and black to the side, although historic photographs suggest that this is a relatively recent approach, with tar a more likely historic finish. There are a small number of rendered buildings painted white, including the Old Hall and agricultural outbuilding by the village green.

Fig. 18 Local soft red and yellow stock brick, laid predominantly in English bond, on old farm building.

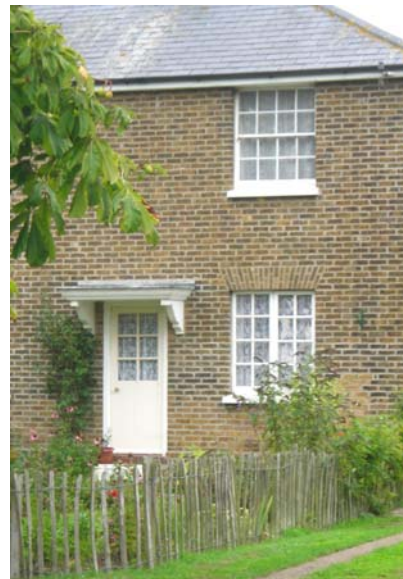
7.13 The traditional fenestration consists of small paned vertically sliding sashes, eight over eight or six over six being common. In brick buildings windows have flat or shallow segmental arched window heads. Pentice boards are used where there is weatherboarding. Small paned casements are also seen. Timber window joinery is generally painted white or black. There appear to be few historic doors that have survived, although there are some older part-glazed doors with small panes, and some examples of vertically boarded doors that have survived on Kents Cottages. Doors may be located to the front or the side, and are sometimes sheltered under small mono-pitched porches or beneath flat canopies on brackets (*Fig. 19*).

Fig. 19 Small paned casements and sash windows, traditional door with simple canopy, no.18 Churchend.

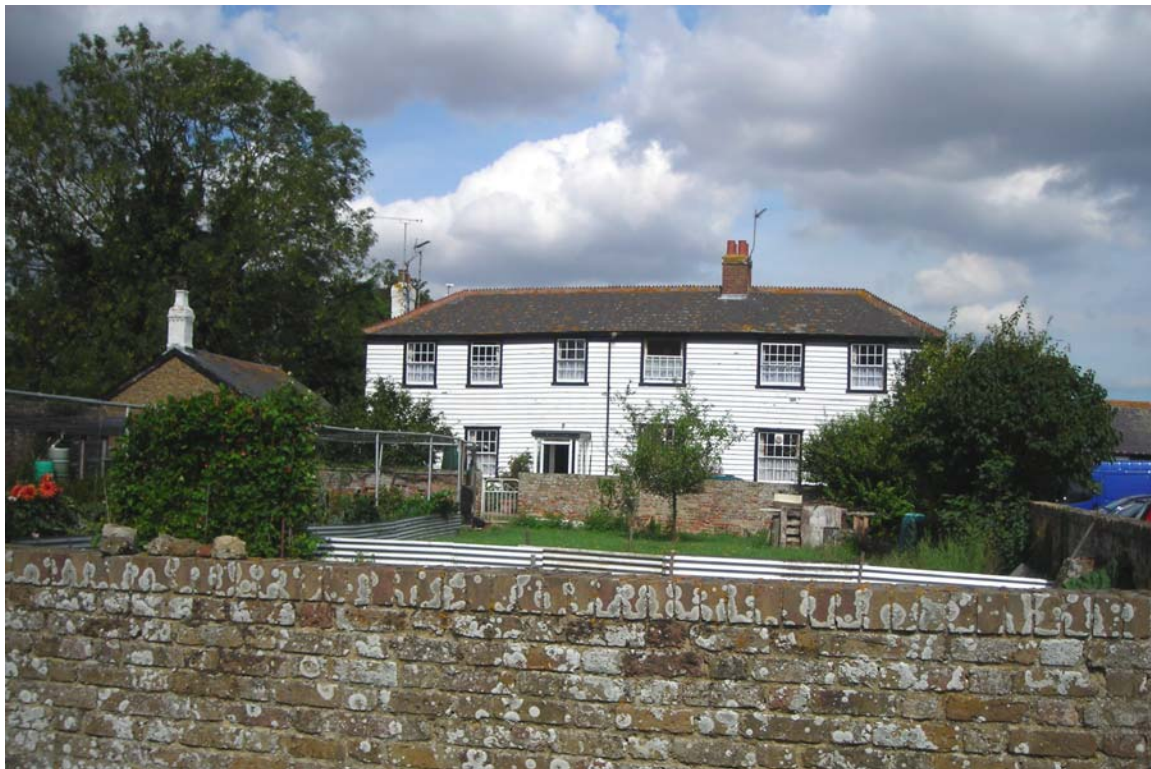
- 7.15 The George and Dragon is a landmark building at the heart of the village, with its prominent white weatherboarded façade, small paned sashes, hipped grey slate roof and distinctive ridge tiles (*Fig. 20*). It is believed to have originally been constructed in the early 17th century. Philip Benton, writing in 1867, notes that it was once two cottages, but was converted to a pub in the late 17th century. As well as the strong visual contribution it makes to the street scene, the pub has an important place in the social and cultural history of the village, not least because of its dubious association with bare-fist fighting. Fights took place in the walled garden in front of the pub, and local legend has it that the high wall between the churchyard and the garden was put up at the request of a reforming vicar so that the congregation could not see these bloody contests. The pub is Grade II listed, as is the 18th century walled garden. The wall of the garden is constructed of vari-coloured local brick. Adjoining the garden and at right angles to the pub is a small single storey pitched roofed brick building with recessed sash windows and a single chimney. It has a mid-19th century appearance, and may have been a wash house or a brew house.

Fig. 20 The George and Dragon pub viewed across the walled garden.

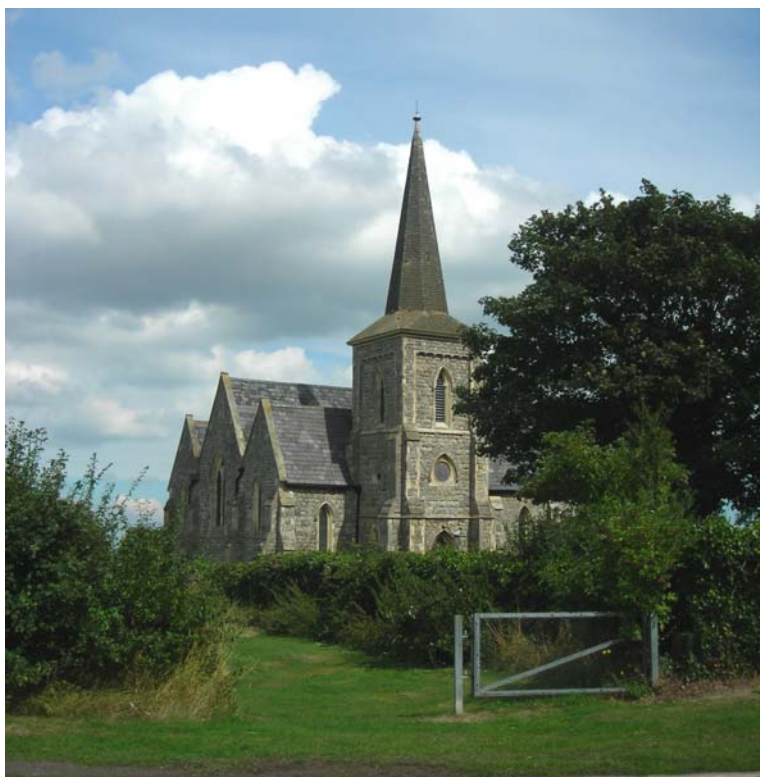
7.16 The garden wall continues along the footpath edge to the churchyard, which is entered through iron gates. The parish church is Grade II listed, and was built around 1853 in an Early English style to the designs of William Hambley (*Fig. 21*). It is constructed of roughly squared grey Kentish Ragstone rubble with stone dressings. A distinctive feature of the church is the range of three steeply pitched grey slate roofs, gabled to east and west. The south tower with its octagonal shingle tower hipped at the base has a noticeable lean. The tower is an important landmark in the flat landscape, marking the location of the village in distant views. The churchyard is partly owned by the Parish Council, and contains a good survival of early gravestones and associated ironwork. A well-cared for war memorial is a feature near the entrance. A number of gravestones are Grade II listed, including the earliest in the churchyard, a headstone memorial for Jonas Allen, dated 1698. The churchyard encompasses the site of the previous timber church, unmarked as such but indicated by the monuments to the rectors Thompson, Ellwood and Archer that, according to Benton¹², once lay within its walls. The churchyard is mostly laid to grass, and is well maintained with mature trees and hedges. The churchyard has been extended in recent years as the old yard became full, which had prompted fears that in the future interment would have to take place on the mainland. The extension is an open grassed area bordered by hedgerow that would benefit from some further tree planting in keeping with the more historic churchyard in order to soften the landscape.

Fig. 21 St Mary's Church.

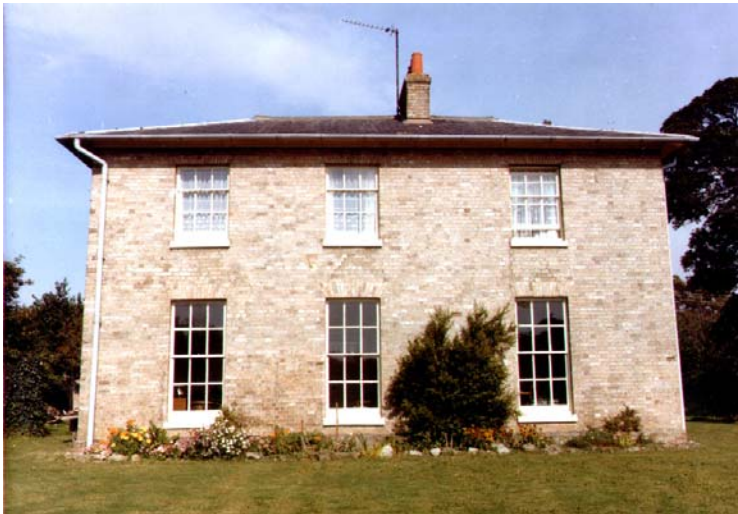
- 7.17 Opposite the church lies the Old Rectory, and this remains church property. It is an elegant stock brick building of 1846, with a shallow hipped grey slate roof and small paned hornless sashes, but with remnants of an earlier late 17th or early 18th century building (*Fig. 22*). The back kitchen was rebuilt in 1793 and survived the 19th century rebuild. The house and grounds are given privacy by the surrounding high boundary wall and trees growing within the grounds as well as outside. The wall is constructed of vari-coloured brickwork, including soft red bricks likely to be from the earlier phase of construction as well as 19th century local stock bricks. The Old Rectory is Grade II listed.

*Fig. 22 The Old Rectory, photographed from within the grounds.
Reproduced with kind permission of R.W. Crump.*

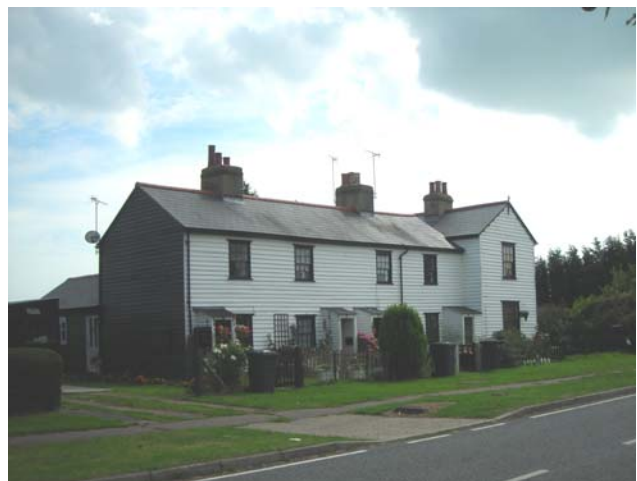
Fig. 23 Kents Cottages.

- 7.18 On the east side of the spinal road at 10-14 Churchend are Kents Cottages, a picturesque Grade II listed terrace of white weatherboarded mid-19th century timber framed cottages with a later addition of a cross wing (*Fig. 23*). This is an important survival of vernacular timber-framed cottages, where many were demolished and rebuilt by the War Department as part of the improvements in the 1920s. They have grey slate roofs with red ridge tiles, with a decorative bargeboard on the cross wing gable. The front entrances have small open fronted and weatherboarded mono-pitch porches with corrugated roofs,

and there are small paned sash windows with black painted joinery.

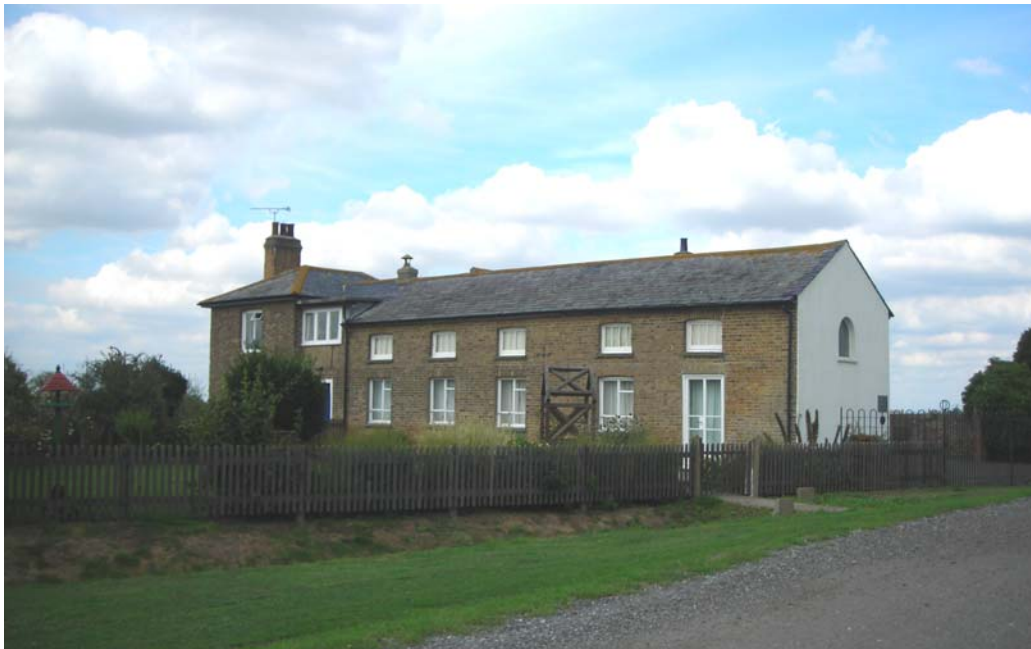
Fig. 24 Former school, now heritage centre.

- 7.20 The old school and schoolhouse which mark the western extremity of the conservation area are an important survival from the Victorian improvements (*Fig. 24*). The school has a special significance in the social history of the community, and reflects a time when the island was more populous than it is today. Constructed of local yellow stock brick widely used in the village at the time, the building reinforces the character derived from the local palette of materials, but has a distinct building form related to its use, with a long low pitched roof range and hipped roof cross wing. Although the arrangement of window openings is original, the windows themselves were replaced with a more modern glazing pattern some time ago. The school playground is still extant, along with some of the outbuildings, retaining evidence of former use. A pair of cottages that once stood alongside the school was demolished soon after WWII. Whilst the school building used as a heritage centre is MoD property, the school house remains that of Essex County Council.

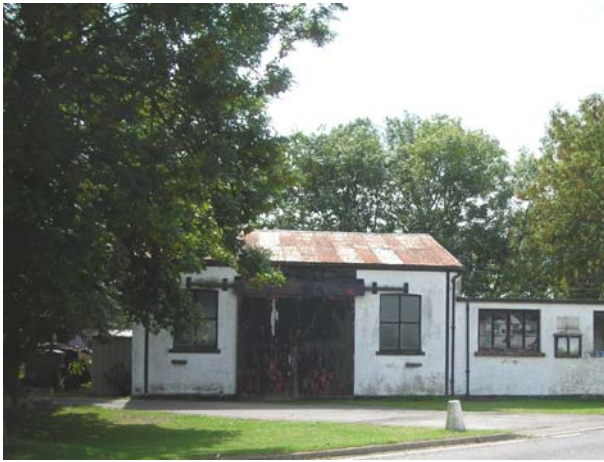
7.22 The agricultural outbuilding on the driveway is a prominent feature in the streetscape from the public road and from the village green, and is also clearly visible when viewed from the approach road into the village from the west (*Fig. 27*). The main range is a high single storey structure with a slack corrugated iron pitched roof and full height plank doors, and two large windows with vertical glazing bars and transoms. There is a flat roofed low single storey extension, part of which has been converted for use as a bus shelter. It is in a poor state of repair, with patchy white render, and joinery in need of repair and a coat of paint. A water tower once stood behind this building.

Fig. 27 Agricultural outbuilding.

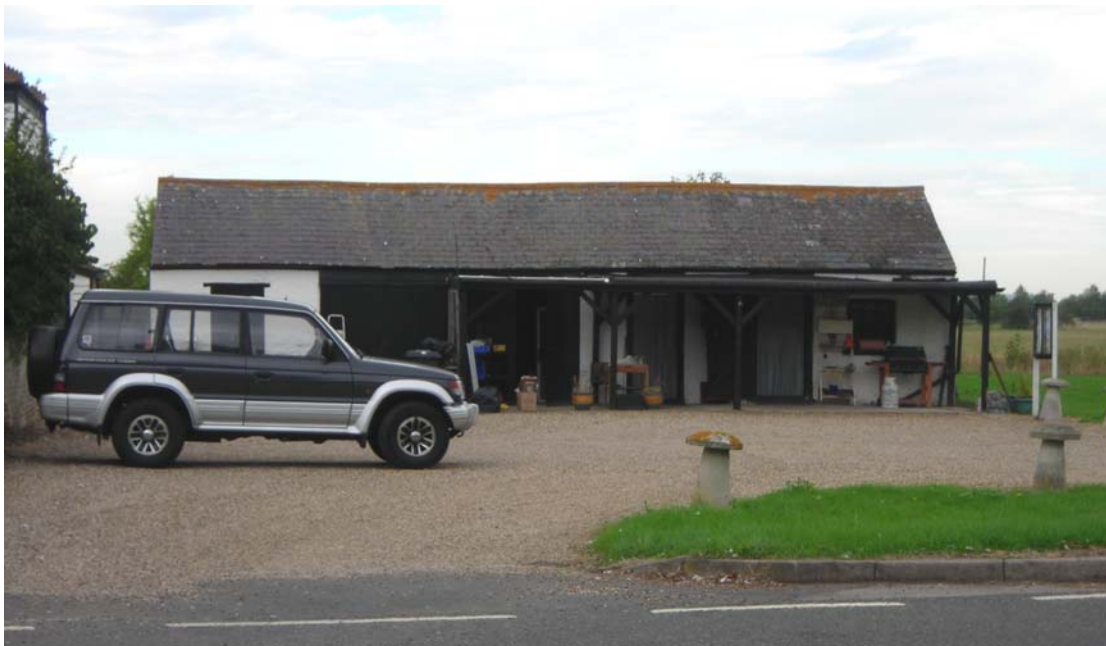
Fig. 28 Village shop adjacent to the George and Dragon.

- 7.23 Adjacent to the listed George and Dragon pub is a long single storey brick built outbuilding with a pitched slate roof which occupies a prominent position where the view opens up at the road junction (*Fig. 28*). This building is used as the village stores and post office, facing onto the car park with a long canopy providing protection for goods on display outside. This has what might be described as a modest 'frontier trading post' appearance which is appropriate in this remote location and is relatively unobtrusive and unspoilt by advertising.

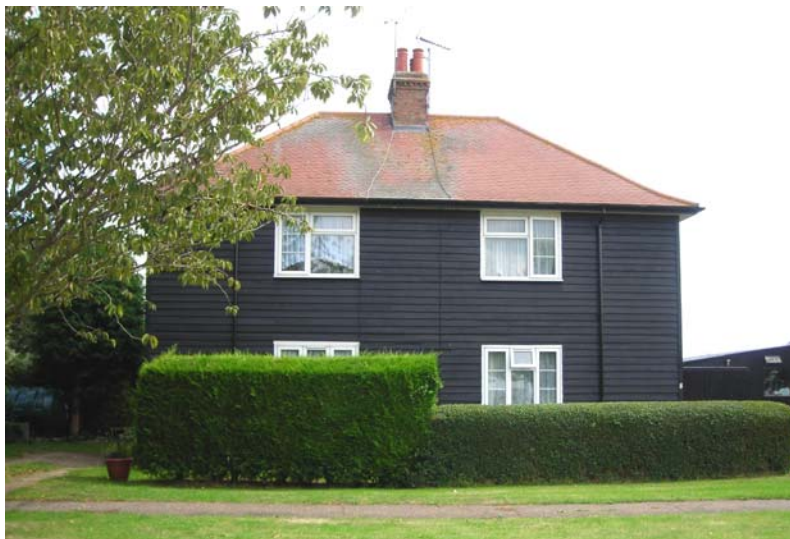
- 7.25 Adjacent to Kents Cottages is a pair of semi-detached two-storey black weatherboard cottages at nos 7-8 Churchend, understood to be part of the 1920s redevelopment (*Fig. 29*). These cottages have a hipped roof of plain clay tiles with a central brick chimney. The windows are flush to the front and are of a modern glazing pattern. Although the front elevation is rather blank, with its simple glazing pattern and lack of elevational detail, these cottages provide a pleasing visual contrast with the adjacent white terrace and the brick cottages to the north.

Fig. 29 Nos 7-8 Churchend.

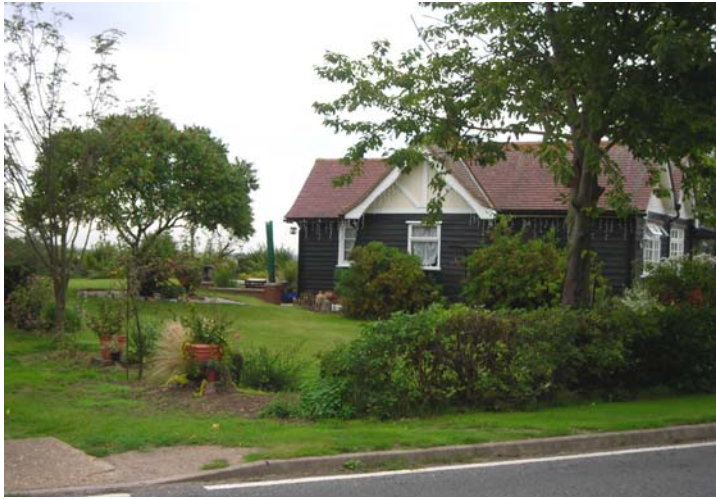
Fig. 30 No. 4a Churchend.

- 7.26 Near the site of the old windmill is a single storey cottage, no. 4a Churchend, predominantly finished in black weatherboard but with rendered gables with applied false timbers and white bargeboards, and clay tiled roof (*Fig. 30*). It is a distinctive and atypical building in the streetscape, but its large open plot and quirky appearance adds interest to the scene. Although essentially 20th century in appearance, its original date of construction is unclear, and it is believed to have developed from an older cottage possibly associated with the old windmill nearby. An old timber shed in the grounds of the cottage is thought to be one of the mill's outbuildings.

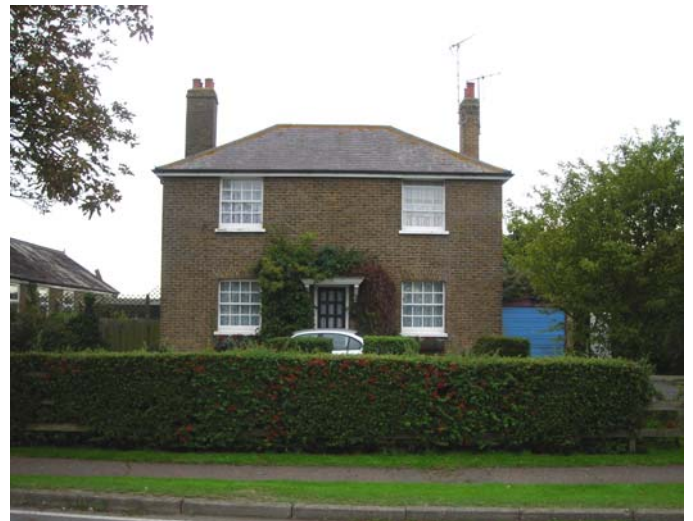
Fig. 31 No.15 Churchend.

7.27 Amongst the 1920s redevelopment are brick semi-detached and detached cottages, numbers 15 to 18 Churchend, built to the north of Kents Cottages to provide homes for the district nurse and policeman (*Fig. 31*). These two storey buildings are constructed of pale stock brick, laid in stretcher bond indicating modern cavity wall construction, with hipped slate roofs. They mostly have eight over eight sliding sash windows and where original doors have survived they are part-glazed timber construction with small panes reflecting the window glazing. The doors typically have flat canopies on moulded brackets. No.19 Churchend is a detached property of this design but with a single storey side extension with a pitched roof of a corrugated material, full height boarded doors

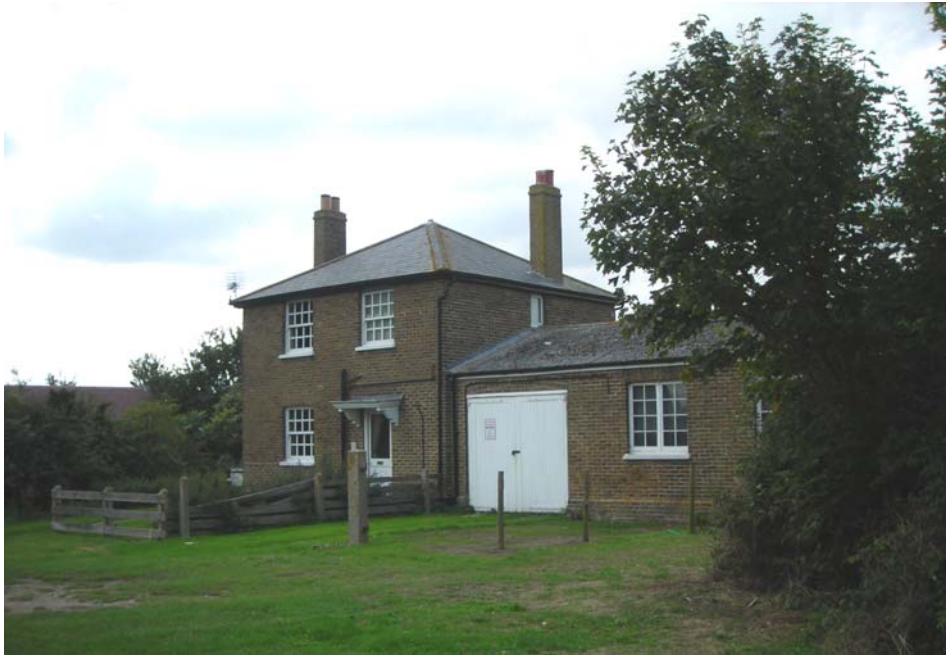
Fig. 32 No. 19 Churchend, former blacksmith's cottage and workshop.

and small paned casement windows (*Fig. 32*). This was formerly the blacksmith's cottage with adjacent workshop.

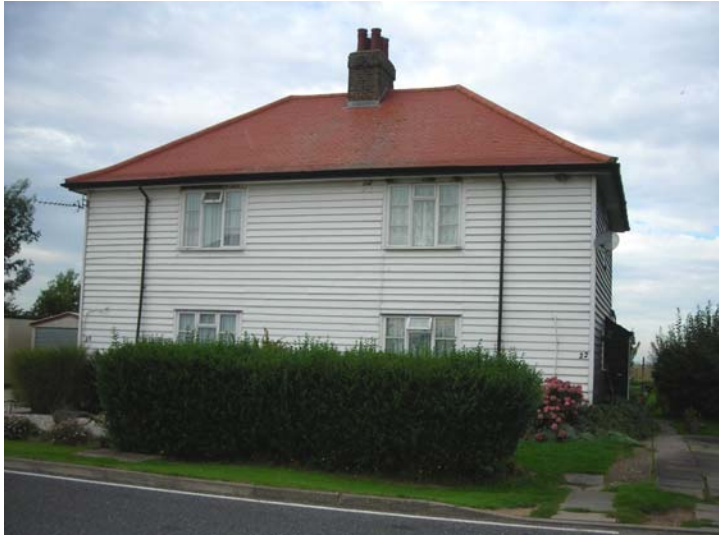
Fig. 33 Nos 22-23 Churchend.

- 7.28 At the southern extremity of the village are numbers 20 to 32 Churchend, cottages constructed during the 1920s redevelopment which are typically two storey semi-detached white weatherboarded cottages, painted black to the side elevations (although there is one single storey property) (*Fig. 33*). They have hipped slate roofs to the east side of the road, and hipped clay tiled roofs to the west, with central chimneys. Those on the west side have been re-roofed with uncambered machine-made tiles which give a flat, uniform appearance, lacking the texture of older handmade clay tiles. Entrances are to the side with shallow mono-pitched porches that were historically roofed with weatherboard, with the lower portions boarded and solid doors. There is now some variety in the form of these porches, some having been closed in, but they are still typically mono-pitched, small and discrete. There is a consistent pattern of fenestration that provides cohesion to the group, with side casements and a central plain window with top vent. Historic photos show small paned casements on some of these properties, suggesting these are later replacements. At least one original outbuilding survives in this group, at no. 28 Churchend, probably a privy, with a weatherboarded exterior and handmade clay tiles (*Fig. 34*). This should be retained as these outbuildings generally seem to have been lost. Care needs to be taken that incremental changes to boundary treatments, as well as introduction of garages, hardstanding and other outbuildings in the large plots do not undermine the cohesion of the group and the rural character of the village.

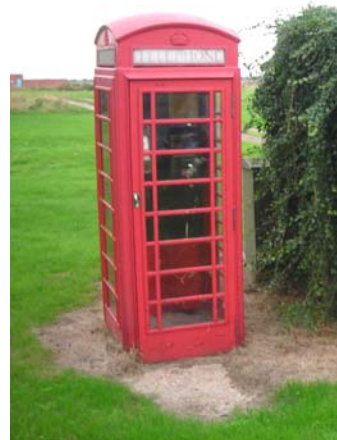
Fig. 35 K6 telephone kiosk.

7.29 On the west side of the spinal road there is a historic K6 telephone box adjacent other street furniture relating to various utilities (*Fig. 35*).

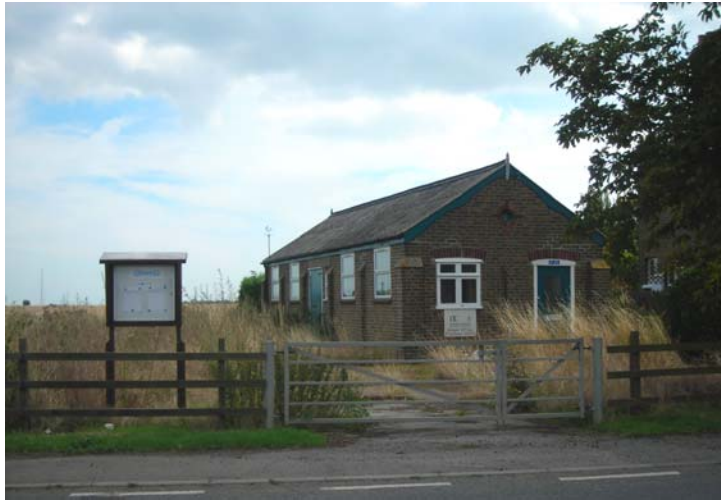
7.30 A more distinctive building that formed part of the 1920s building programme is a long single storey structure at right angles to the road (*Fig. 36*), of yellow local stock brick with shallow brick buttresses to the sides elevations and corners, full height plank doors to the side, a pitched corrugated roof with small pendant finials at the gable ends and a round window at the gable. This building is what remains of a maintenance yard built for the Royal Engineers, and included an office, carpenters' yard and builders' yard. It is now used by QinetiQ as an estate office. Its brickwork clearly associates it with the domestic dwellings built to the south at the same time, and therefore it forms part of a distinctive group that contributes to the local character of the village.

Fig. 36 QinetiQ estate office.

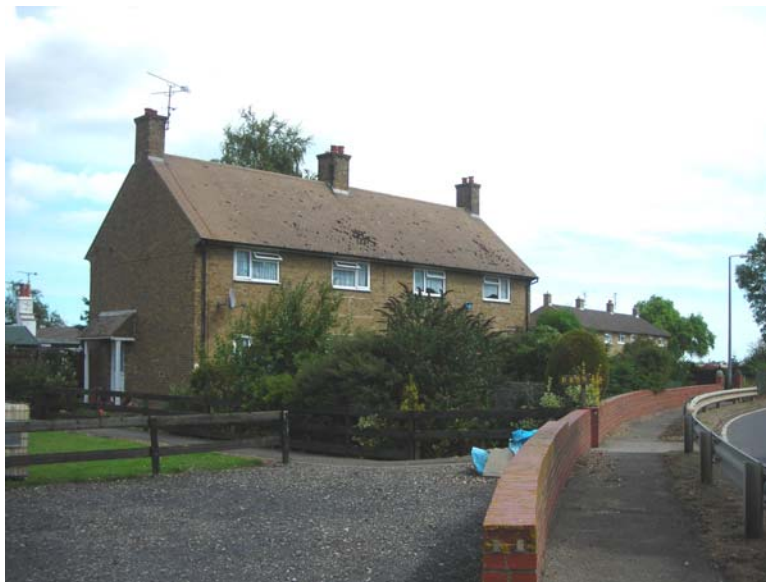
- 7.31 Churchfield Cottages are of 1920s or later construction, with yellow stock brick in stretcher bond and pitched roofs of modern machine-made plain tiles or pantiles (*Fig. 37*). The windows are UPVC with a horizontal emphasis in a simple glazing pattern with plain side-hung casements with top vents. Some have recessed glazed UPVC doors with side lights, or there are side entrances under mono-pitched tiled porches. Although modern in appearance, the use of yellow brick and the scale and simplicity of design of these properties suits the area well, and the generous gardens contribute to the spacious character of the area. Nos 1-2 Churchfield Cottages has a summer roosting population of long-eared bats which is a consideration when undertaking repairs to the building.

Fig. 37 Churchfield Cottages.

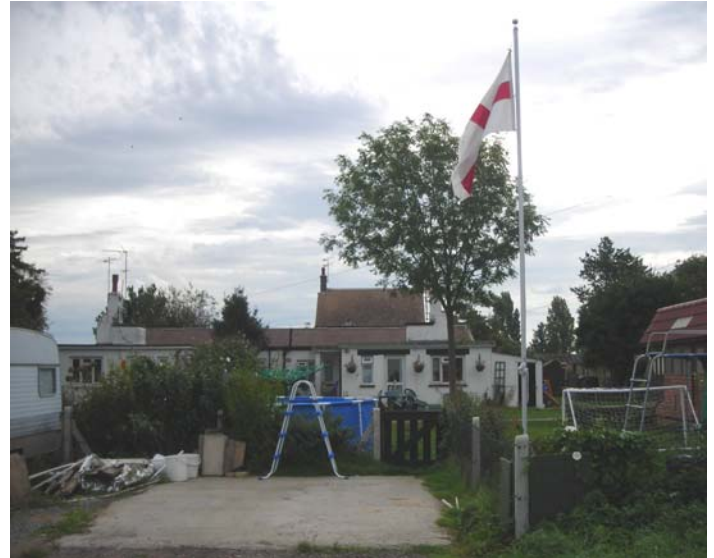
Fig. 38 Second World War cottages.

7.32 To the rear of Churchfield Cottages and accessed by a track from the road are a pair of semi-detached white rendered single storey properties, built during WWII to provide accommodation for workers at a top secret military installation, the remains of which lie in fields just outside the conservation area (*Fig. 38*). These properties have been much altered with modern interlocking tiled roofs and replacement windows and doors, and have a rather untidy boundary. Although a track passes in front of the cottages around the field edge, they are barely visible from the public road or public footpaths and can only be glimpsed from the village green, so they do not directly contribute to the street scene. However these distinctive properties are a reminder that this

quiet rural village owes much to the military operations across the island.

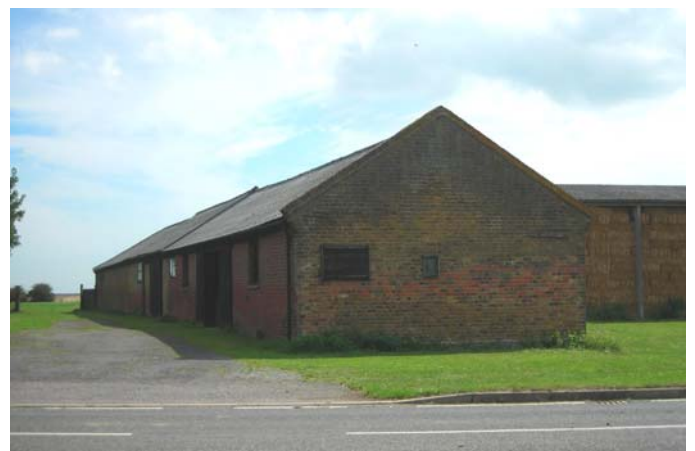
Fig. 39 Early range at Old Hall Farm.

7.33 Of the main farm complex at Old Hall Farm little remains of what appears on historic maps as a three-sided courtyard arrangement. However one long single storey brick range has survived, now dominated by large modern agricultural sheds (*Fig. 39*). The fabric of this building includes early soft red brick perhaps of 18th century date as well as the local yellow stock brick introduced in the mid-19th century. The building has a corrugated roof, with raised parapets at the gable ends and full height boarded doors. This structure is a valuable element in the streetscape both in its use of local materials (there is only a limited survival of early local red brick) and also as a reminder of the continuity of

historic farming that has been an important feature of the settlement for centuries.

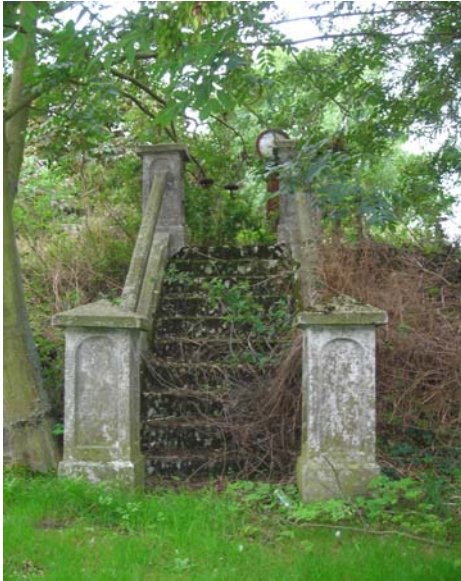
- 7.34 Tucked behind the bus shelter is a scrubby mound with grand but overgrown steps rising to its summit, where there is an iron pillar gauge (*Fig. 40*). This is what remains of waterworks believed to date from around 1886, which included a pumping plant and associated water tower¹⁴. The introduction of a fresh water supply to the island was an important feature of the Victorian improvements that provided a regular local supply of fresh water. The grandeur of this feature is indicative of the importance of the development to the welfare of the islanders, but it is now in a state of romantic decay. It would be a pity to see this feature lost to encroaching scrub and neglect.

Fig. 40 Steps to waterworks.

- 8.9 The site of the water pump is also neglected at present. This is a distinctive local feature with an important place in the history of the island, but is in danger of being forgotten and engulfed by scrub. Some basic clearing of vegetation should be undertaken to prevent loss and damage to this feature.

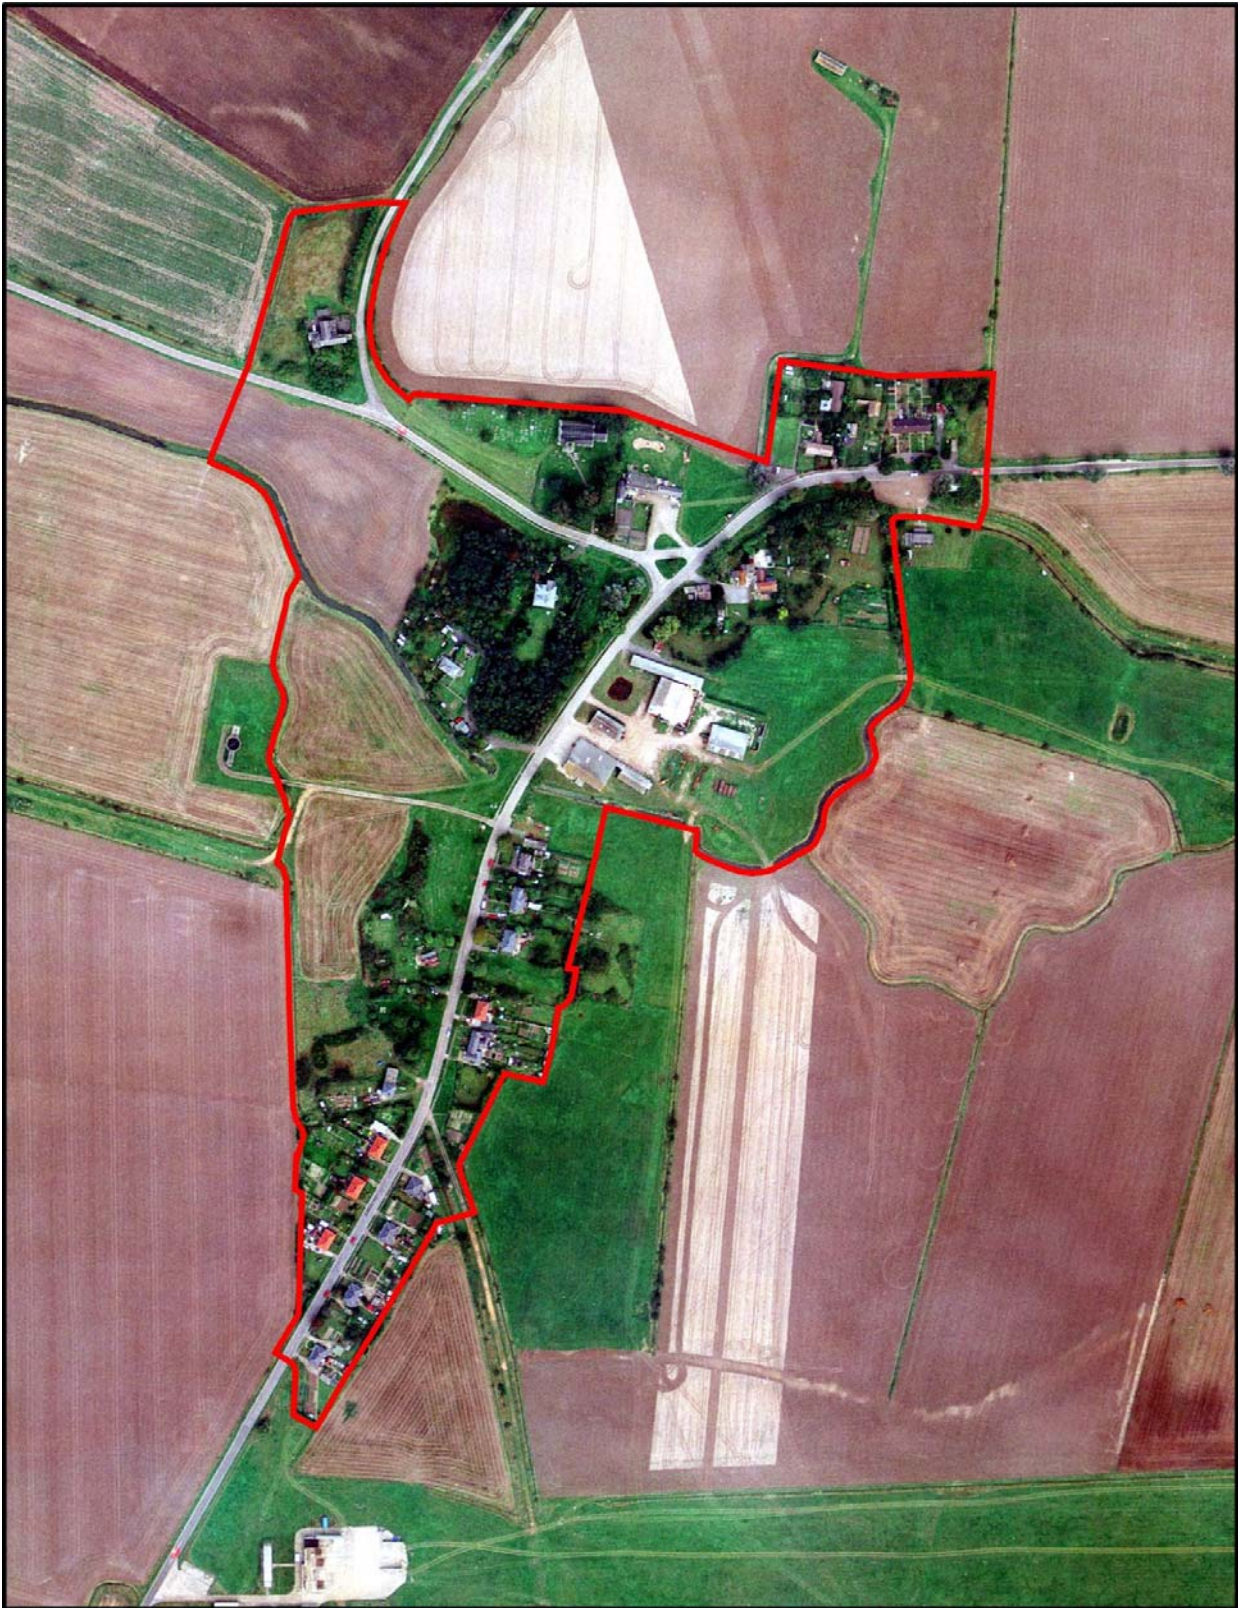
- 7.35 The conservation area is green and spacious, as can be seen from an aerial photo of the village (*Fig. 42*). In addition to the contribution of the surrounding landscape setting, trees, open green spaces and gardens make an essential contribution to the special character throughout the conservation area. Domestic gardens are important, with properties typically set in large plots with gardens that are often well planted, aided by the excellent quality of the soil. Hedges often form the front boundaries of properties, enhancing the green and rural character of the village. The village green is an expansive green open space at the heart of the community which is a valuable amenity area. There is also an enclosed grassed play area to the south of the village that provides a safe environment for children. The churchyard provides further extensive green space within the conservation area which has been extended westwards in recent years.

©UK Perspectives
Fig. 42 Aerial photograph of conservation area.

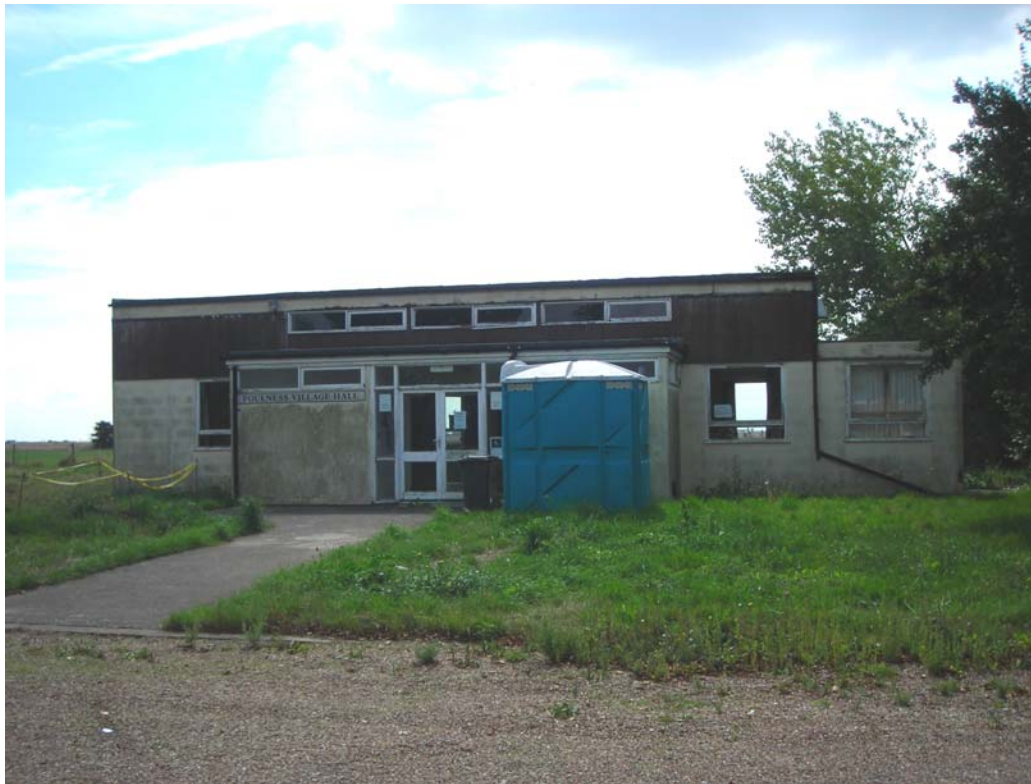
7.38 In the main properties appear to be in a reasonable state of repair and well maintained, but there are some exceptions. These include the agricultural outbuilding near the Old Hall, which is a prominent feature in the streetscape, and perhaps suffers from a lack of useful purpose (apart from as a bus shelter!). The patchy render and rotten joinery create a neglected appearance that detracts from the street scene. The rear elevation of the George and Dragon, which is clearly visible from the village green is also a little neglected. The village hall, although excluded from the conservation area, is highly visible from the public highway and its run-down state intrudes on the character of the area (*Fig. 44*). The building is a late 1960s low rectangular structure with a flat roof, and a lower flat roofed front extension with a glazed entrance and a horizontal arrangement of windows at a high level. It is rendered in part with timber cladding, and the timber joinery of the windows and doors is in a poor state. The surrounding plot opens directly onto the gravel parking area to the front and is unkempt and overgrown.

Fig. 44 Village Hall.

- 8.8 Properties that appear neglected detract from the attractive visual character of the conservation area. The village hall is an eyesore that is desperately in need of either repair with tidying and landscaping of the plot, or demolition to be replaced by something appropriately designed. As the building is adjacent to the conservation area, any new building would have to conform to strict design criteria in accordance with policy BC1 of the Rochford District Replacement Local Plan. The treatment of the plot should respect the old byway that leads eastwards away from it. The agricultural outbuilding near the Old Hall requires basic repair and maintenance of the exterior which would reduce the negative impact that the building has in the streetscape. Ideally a new use should be sought that would not involve unsympathetic alteration.

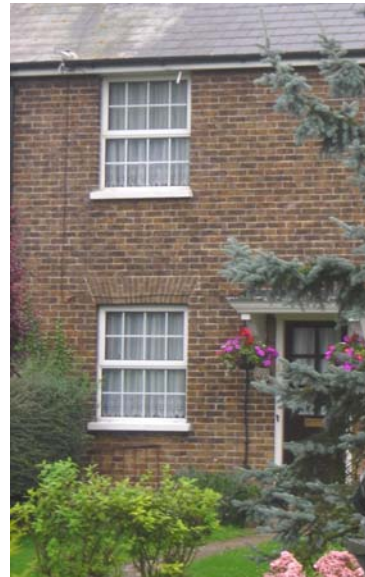
7.39 In the past repairs and upgrades of properties have resulted in loss of original features and some unsympathetic alterations, particularly with regard to replacement windows (*Fig. 45*). Historic fenestration makes an important contribution to the character of individual buildings and to the overall character and appearance of the conservation area. Other examples of inappropriate modernisation include replacement of historic doors and roofing materials.

Fig. 45 Replacement UPVC windows, no. 17 Churchend.

- 8.6 In the past property repair and maintenance within the conservation area has involved the loss of historic fabric and features. Listed buildings are the subject of quinquennial reviews, and plans are underway for these to include not only a condition report on the buildings but also a plan for any works required. However unlisted buildings also contribute to the character of the conservation area, including historic and more recent 20th century buildings. A repair and maintenance programme should be in place that takes into account the particular features of properties that contribute to the special character of the conservation area. This should also include provision for enhancing the area by reinstatement of features where they have been lost, for example in the case of traditional fenestration and doors. Unauthorised alterations such as changes to windows and doors and exterior painting are not permitted under the terms of tenancy agreements, and can therefore be managed by Defence Estates to ensure the special character of the built environment is preserved and enhanced. Boundary treatments must also be a feature of the plan, with proper maintenance of historic walls which are an important element in the conservation area.

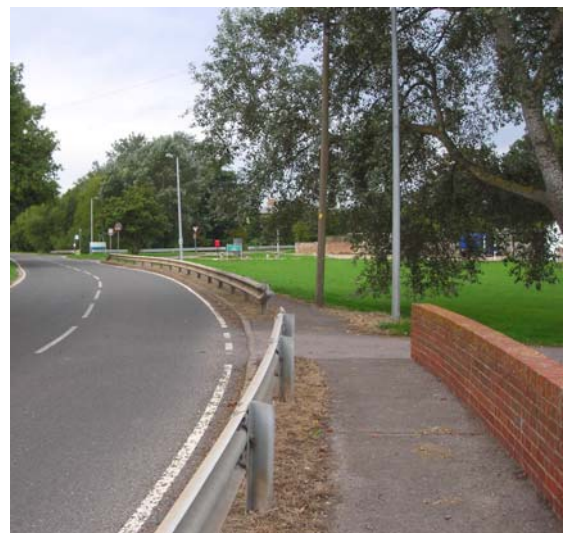
7.40 Generally the public realm is well maintained, and is tidy, rubbish-free and unvandalised. However the street scene is marred by a proliferation of street signs, street furniture and road markings, much of which derives from rather heavy-handed traffic management. This creates a cluttered appearance that detracts from the unspoilt rural character of the village. This is particularly evident around the road junction opposite the village green (*Fig. 47*). As well as the high level of clutter, the design of the street signs and furniture fails to take into account the historic character of the setting. Street lighting is out of scale with the village context. The low metal crash barrier where the road turns eastwards is a particularly poor example that fails to respect the character of the area (*Fig. 46*). A low modern wall of bright red hard brick at the edge of the pedestrian footpath is also an overly harsh feature.

Fig. 46 Crash barrier.

sparingly within the historically sensitive village environment whilst maintaining safety standards, and existing markings should be reviewed with a view to future simplification. As a general principle, a minimalist approach to traffic management is recommended.

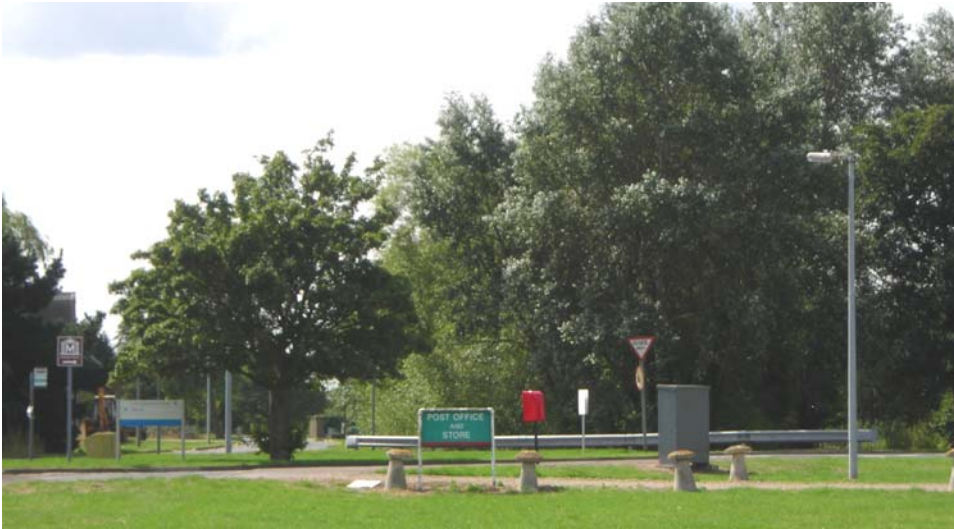
Fig. 47 Street clutter around road junction.

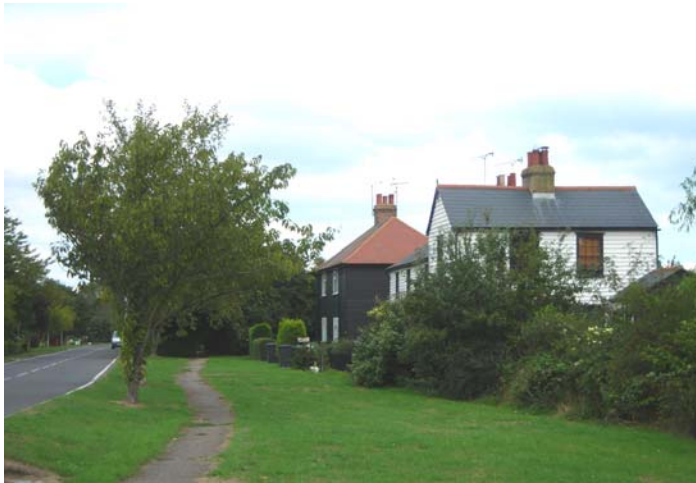
Fig. 48 Soft verges along spinal road.

- 8.1 Soft verges are a characteristic feature of the village and should be retained (*Fig. 48*). The use of hard edges and kerbs should generally be avoided. Rough demarcation of pedestrian footpaths and carriageways enhances the rural character of the village (*Fig. 49*).
