Local Development Framework
Evidence Base

Paglesham Church End
Conservation Area Appraisal and
Management Plan

The document was prepared by Karen Fielder, MA, PGDip. Of Essex County Council's Historic Buildings Section:

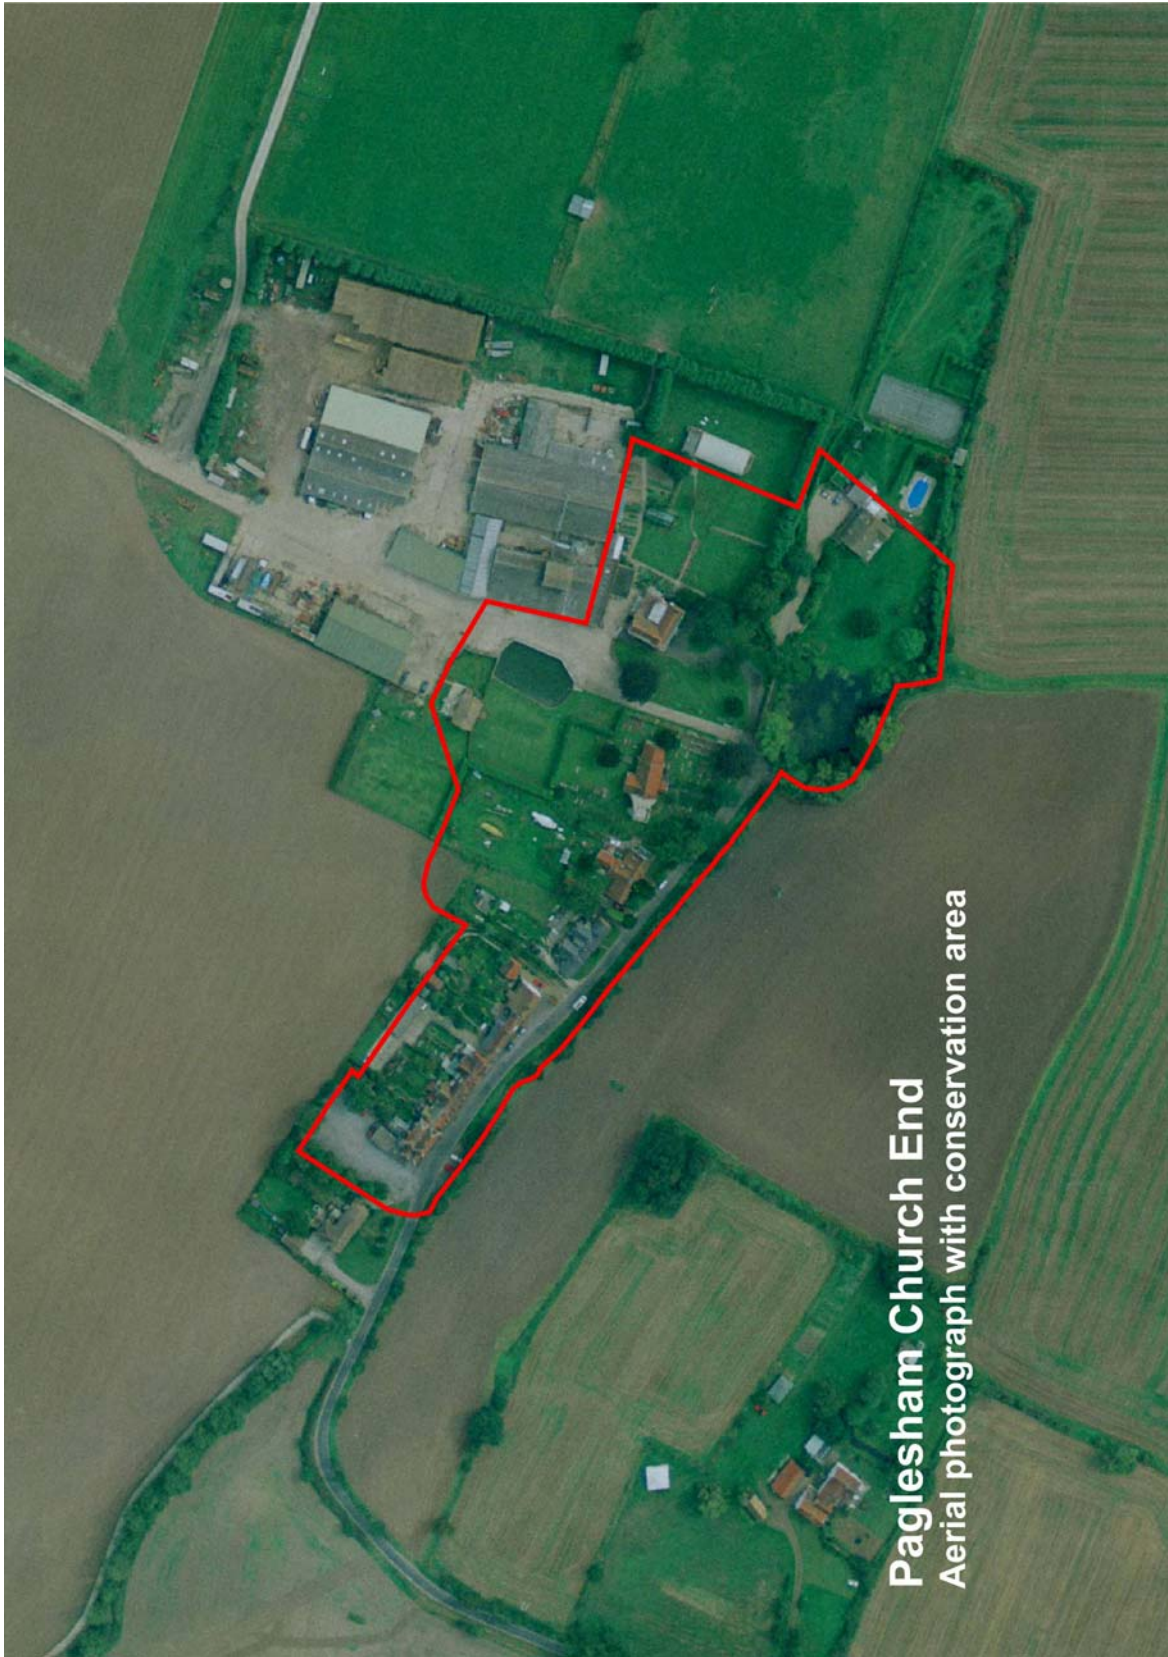
Fig. 2 Aerial photograph of Church End, showing conservation area boundary.

- 5.3 Historically the marshlands fringing the settlements were grazed, particularly for sheep pasturage. Today the land is mostly ploughed and the setting of Church End in open arable farmland is an important element in the special character of the settlement (*Fig. 2*). The marshlands began to be drained in the medieval period creating fertile soils for cultivation, and piecemeal embankment and drainage took place until the final enclosure in 1774. The tithe map of 1840 shows a historic rectilinear pattern of fields that is typical of Rochford District, and which may be of medieval or earlier origin. There has been some loss of hedgerows since the Second World War which has created large prairie fields, and has to some extent resulted in the erosion of the historic field pattern and landscape quality.

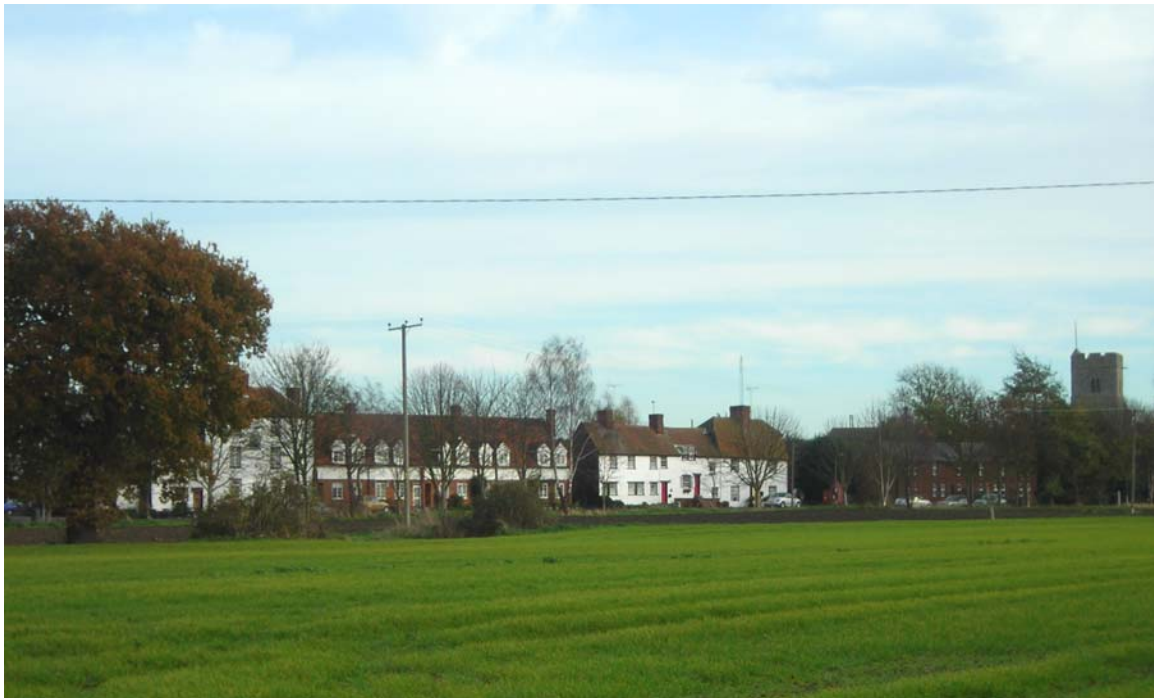
Fig. 11 Church End viewed from the Church End road.

- 7.2 Church End is approached from the west along a narrow road that winds through flat arable fields passing occasional farmhouses and cottages. The distinctive one-sided development at Church End with its white weatherboarded façades and church tower is visible from the south across fields between the road-side trees. Although this view is more obscured when the trees are in leaf, it presents an attractive approach to the hamlet. The protection of the south side of the road at this point from development should be a material consideration when assessing proposals that might affect the setting of the conservation area (*Fig. 11*).

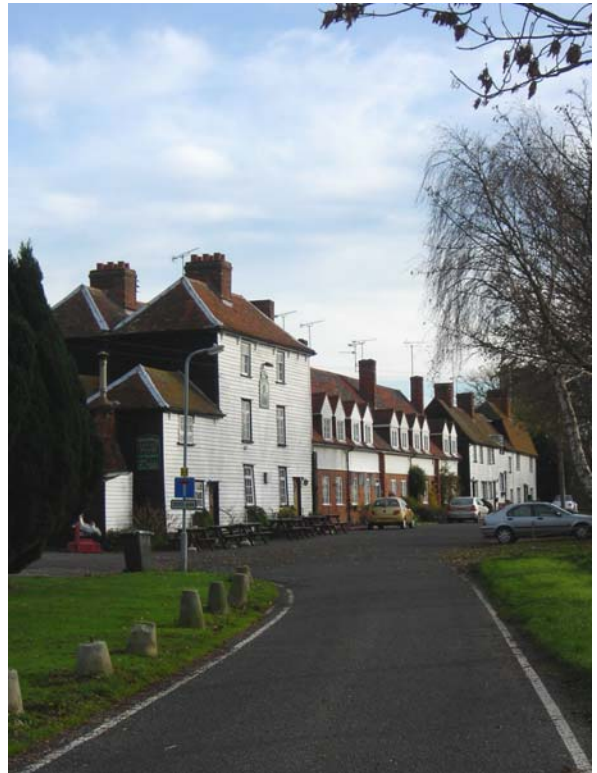
Fig. 12 North side of the Church End road.

7.3 The north side of the road is closely built up to the edge, with a sense of enclosure in contrast with the open and undeveloped south side (*Fig. 12*). The enclosure is broken at Church Hall Farm, where the old Hall is set back in a large garden plot with a low boundary wall, lawns and occasional trees. A private road heads north into the farm complex and provides access to Church Hall Farm Cottages. The long view to the east end of the road is closed by trees in the churchyard, around Winton Haw and around the pond. The southern edge of the road is bordered by a dry ditch and well spaced mixed species trees (*Fig. 13*). From here there are important views south across the arable landscape, particularly to Finches and Moules.

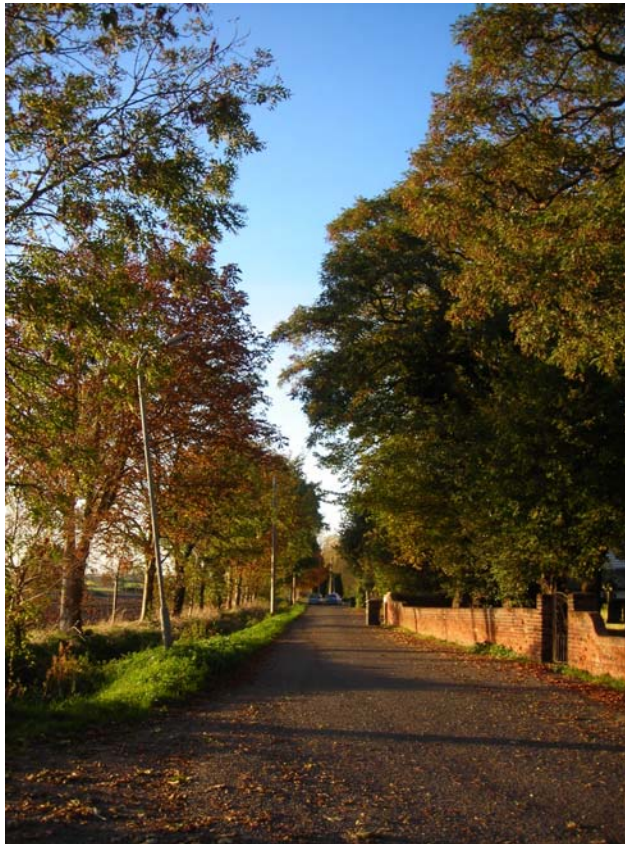
Fig. 13 Looking west with the tree-lined south side of the road left and the churchyard wall right.

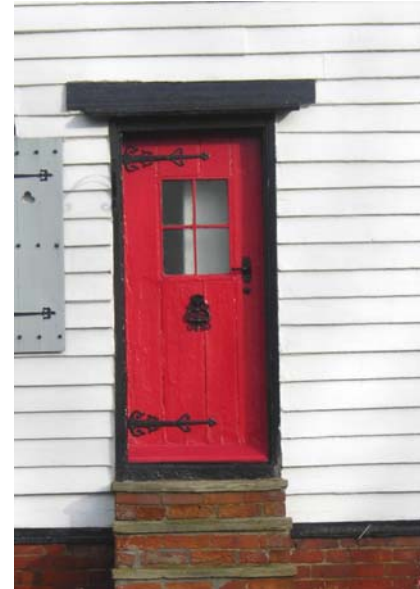
Fig. 14 Painted boarded door, Post Office Cottages.

- 7.8 Traditional windows are white painted timber vertically sliding sashes with small panes (*Fig. 15*). Some of these are asymmetric with smaller top frames. Small paned side-hung timber casements are also seen, as at Old Worlds End. In traditional brick buildings the window and door heads consist of segmental brick arches or flat arches with voussoir bricks (at Church Hall). Windows and doors in weatherboarded buildings often have small black painted pentice boards and simple black painted surrounds. Most of the doors in the conservation area are 20th century, but traditional painted timber panelled and boarded doors are seen, at The Post Office Cottages for example (*Fig. 14*).

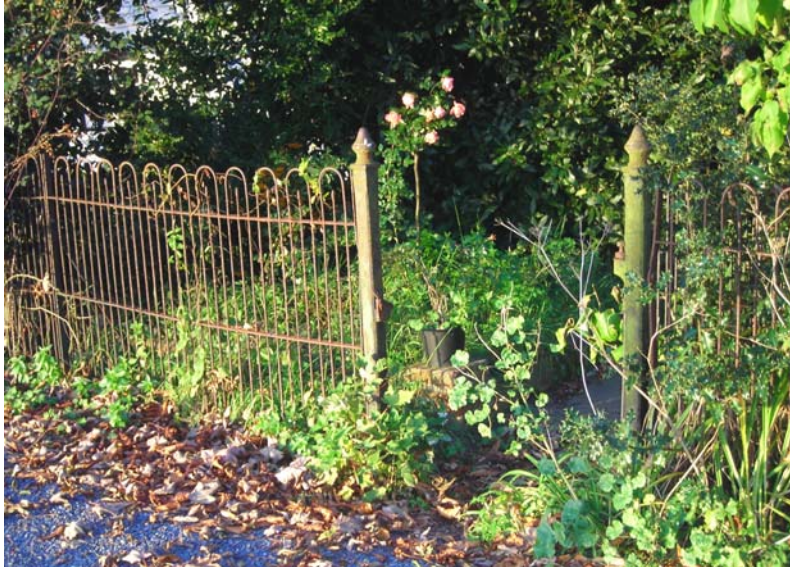
- 7.9 Boundary treatments can make an important contribution to the character of a conservation area, and at Church End they are generally low key and informal. Picket fences, post and rail fences and hedging are all appropriate for the rural context of the conservation area. Many historic boundary fences have been lost, and picket fences were once more common for domestic cottages than they are today and would benefit from reinstatement if opportunities arise. Many of the cottages now have narrow forecourt strips with various hard surface finishes and attractively displayed with pots, a treatment which is not out of keeping with the informal character of the area. Simple old iron railings are used at Old Worlds End, and this is also a suitable treatment for the rural setting (*Fig. 16*). Timber or metal field gates are used across driveways and these are appropriate to the context. Trees and hedging are used to provide screening around Winton Haw, but the use

Fig. 16 Railings at Old Worlds End.

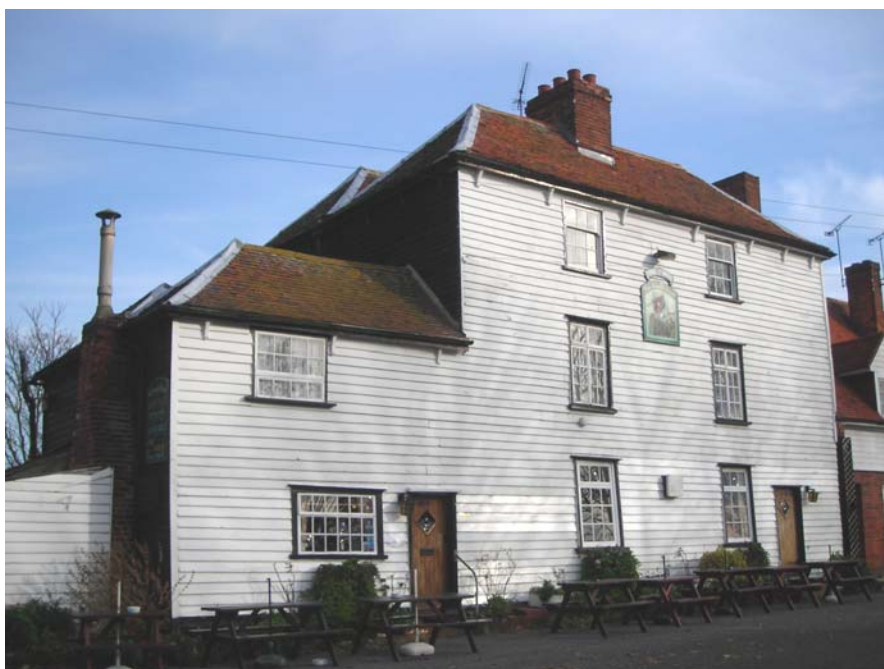
Fig. 17 The Punch Bowl Inn.

- 7.10 The Punch Bowl Inn is a landmark building, dominating the approach to the conservation area (*Fig.17*). It is Grade II listed, and is timber framed with 18th and 19th century features, with a two storey left range and three storey right range, and double pile hipped roofs with clay tiles. It is believed to have been a sailmaker's in the past. The Punch Bowl Inn was previously located with other cottages on a track leading south from Church End to the school, before it opened in its current premises sometime between 1849 and 1873. The field opposite was used for annual fairs. The attractive appearance of the pub benefits from minimal advertising, with just one traditional timber sign on the front elevation and one to the side. The windows are not original, and there are some top hung vents which are not traditional. There is a poor metal flue on the left-hand lean-to which once had a taller brick chimney stack. Like many pubs it suffers from a poor car parking area to the side, with patch-repaired tarmac surfacing, and this would benefit from improved landscaping whilst retaining an informal character (*Fig. 18*). There is also a small pull-in car parking area on the other side of the street which could be better presented – the rails here are collapsing.

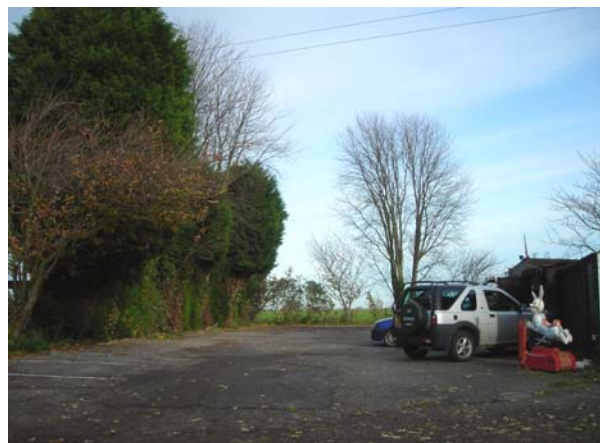
Fig. 18 The Punch Bowl Inn car park.

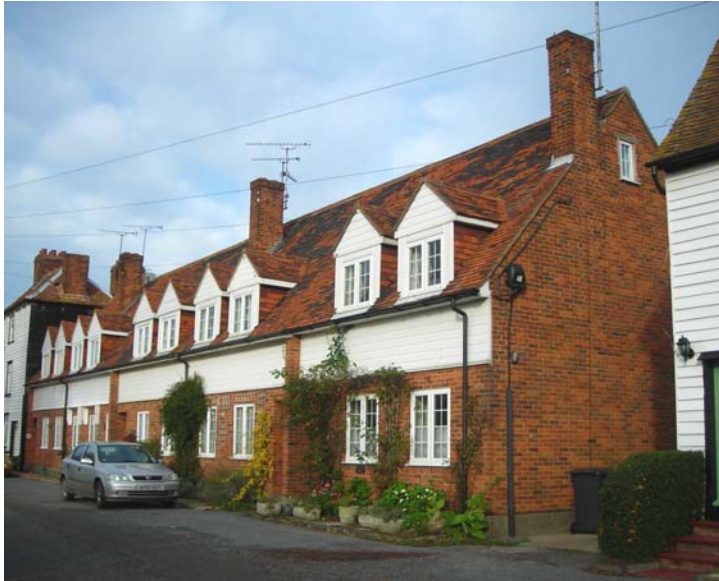
Fig. 19 Punchbowl Cottages.

- 7.11 Adjacent to the Inn is a row of single storey cottages with attics, Punchbowl Cottages, which at first glance appear to be older properties that fit well in the street scene (*Fig. 19*). Built in the mid-1960s they are of modern construction with stretcher bond brickwork and modern materials, and are constructed in a style that resembles the cottages that they replaced as seen in *Fig.9*. The original cottages were weatherboarded to a lower level, with fewer attic dormers and a gambrel clay tiled roof, and doors with simple small canopies on brackets. No. 1 Punchbowl Cottages has small paned metal casement windows and timber weatherboard cladding which are presumably original to the 1960s build, whereas the others in the row now have plastic cladding and windows (*Fig. 20*). Some of the recessed doorways have been closed in, which undermines the cohesiveness of the row. Despite the modern construction, this row of cottages makes a valuable contribution to the special character of the conservation area. They are not listed, but they are occupy a prominent place in the street scene. It is important to preserve their integrity as a unit, and also to encourage the reinstatement of more traditional materials including timber cladding and windows in keeping with the special qualities of the built environment.

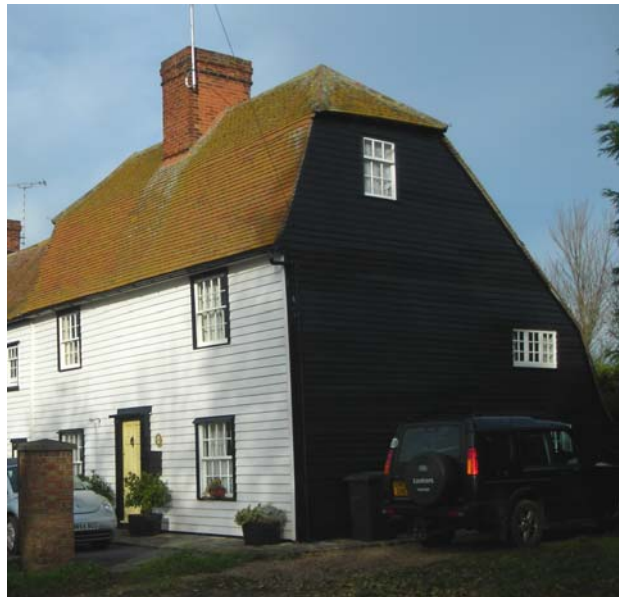
Fig. 21 Old Post Office.

7.12 Post Office Cottages and the Old Post Office was previously known as Shop Row. Atkinson's supply store and post office was located here in what is now called the Old Post Office, which closed in 1973 (Fig. 21). The cottages are timber framed and weatherboarded, with 18th century features although they are possibly older in origin, and are all Grade II listed. They once had picket fence front boundaries, but now have narrow open forecourt areas attractively arranged with pots, a treatment which is not out of keeping with the informal rural character of the area. The front doors of Post Office Cottages are rather curiously arranged at ascending heights (Fig. 22). The appearance of the Old Post Office at the right hand end of the row has changed somewhat having been sensitively converted for residential use - the shopfront on the right hand corner has disappeared and two small catslide dormers in the roof have also been lost.

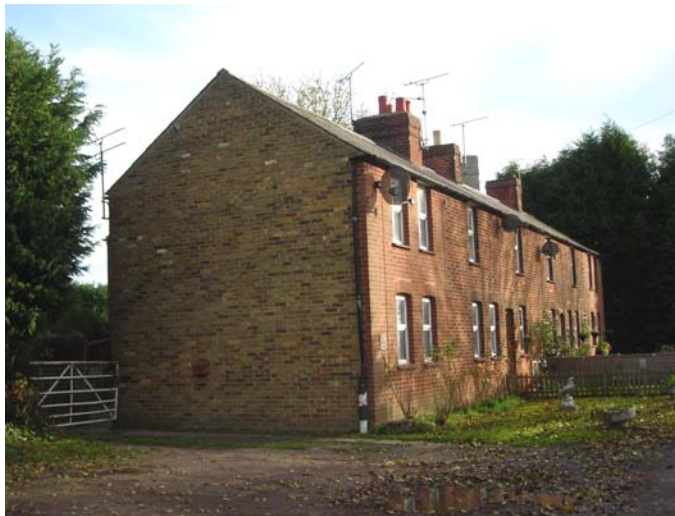
Fig .23 Brick Row.

- 7.13 Outside the Old Post Office is a small group of street furniture which includes a cast iron K6 telephone box, a type designed by Sir Giles Gilbert Scott in 1935. This is Grade II listed. This could be an attractive feature in the setting but is in need of maintenance including cleaning and/or repainting.
- 7.14 Brick Row is a row of 19th century cottages with red brick façades, yellow stock brick side elevations, and slate roofs (*Fig. 23*). These cottages have suffered from unsympathetic alterations, particularly replacement UPVC windows where they originally had small paned vertically sliding sashes. The front gardens are open or have informal timber boundaries including posts and picket fences, and would benefit from the reinstatement of picket fencing to reinforce the cohesion of the row.

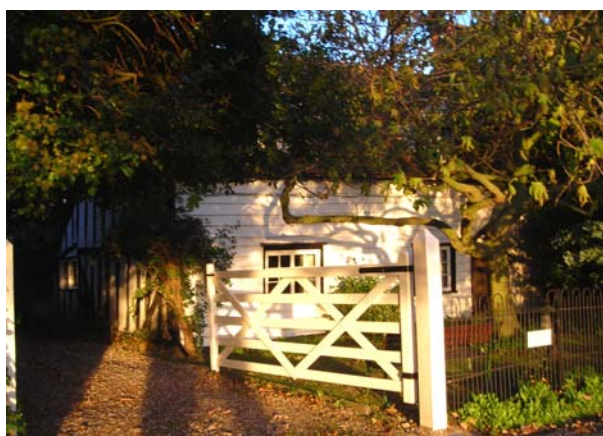
Fig. 24 No. 1 Old Worlds End.

7.15 Nos 1-2 Old Worlds End are a pair of semi-detached timber framed weatherboarded cottages, single storey with attics (*Fig. 24*). The property nearest the church has seen a number of uses, including as a Dame school, beer house and later a shop. The cottages are 16th or 17th century, or earlier, with later alterations and additions, and are Grade II listed. No. 1 recently had grant-aided replacement windows installed. This charming pair of cottages is now barely visible behind rambling front garden planting. Although this contributes to the informal rural character of the street, it would be a pity if they became too obscured as they make a positive contribution to the special character of the conservation area. Rear access is provided by a grassy track which runs along the west boundary wall of the churchyard (*Fig. 25*). There is an old brick outbuilding here that may relate to one of the former uses of the property, and outbuildings are shown here on the tithe map of 1840. Together with the churchyard wall the building has been overwhelmed by encroaching ivy and scrub, but traditional outbuildings of this type can make a positive contribution to the special character of the conservation area., particularly where rear areas are visible from the highway.

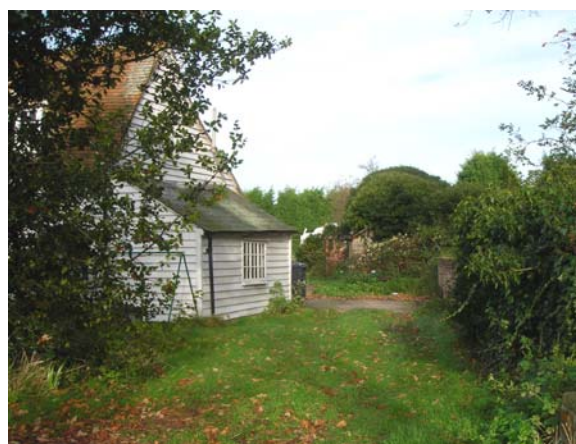
Fig. 25 Rear access, no. 2 Old Worlds End.

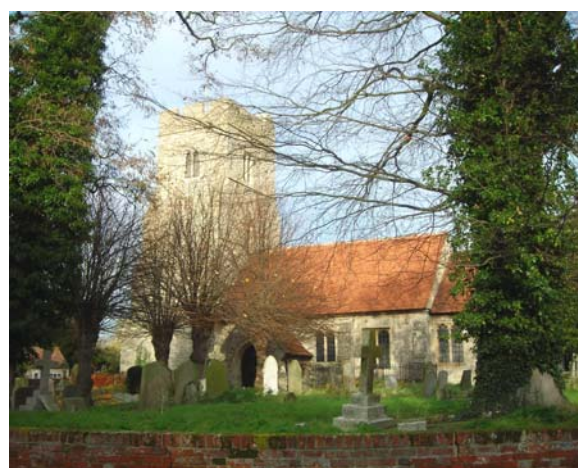
Fig. 26 St Peter's Church

7.16 There has been a church at Church End since at least 1066. The present building is mainly 15th century but with some 12th century elements in the chancel and nave, and a 16th century west tower. The 19th century south porch is approached along an attractive tree-lined path (*Fig. 26*). The church is constructed of stone, flint and septaria with some Roman bricks incorporated into the fabric. By the 1880s it had fallen into a state of dilapidation, but money was raised by subscription for a major restoration in 1883, when the roof was rebuilt and the vestry and south

porch were added. The church has undergone various repairs throughout the 20th century, but its condition is not as good as it should be. Part of the churchyard around the tower is currently roped off with plastic barriers due to the potential hazard from falling stonework.

- 8.1 Responsibility for the repair and maintenance of the church lies with the parochial church council. This is a heavy responsibility for a small parish such as Paglesham. Whilst acknowledging the difficulties involved, every effort should be made to prevent the condition of the building deteriorating further. Rigorous basic maintenance regimes, including regular clearing of ivy and scrub away from the building, would help and need not be costly. Grants can be secured to ensure an effective and manageable programme of repairs can be put in place. The west window is a particular priority, and the boundary wall should not be forgotten. English Heritage have recently launched their 'Inspired' campaign to tackle the problem of caring for places of worship. Further advice and information is available on their website at www.english-heritage.org.uk.

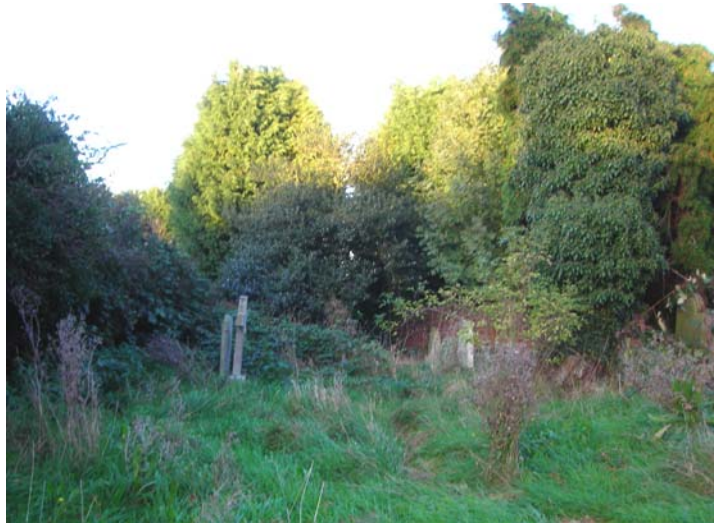
Fig. 27 Churchyard.

7.17 The churchyard is bounded by a low red brick boundary wall mainly with soldier brick capping but some stone capping. As well as some 17th and 18th century gravestones, the churchyard contains an excellent survival of 19th century gravestones and ironwork. These include the graves of a number of important local families including the Browning and Wiseman families who were successful oyster merchants at East End, and the infamous smuggling family, the Blyths. The churchyard is still in use, but has become overgrown particularly to the north, and some of the gravestones are overwhelmed with scrub (*Fig. 27*). Although it should be noted that since appraisal a rota of volunteers has been established to help clear scrub and maintain the churchyard. The wall is suffering in places under the weight of encroaching vegetation particularly on the west side. On the south side the boundary wall along the street edge is in poor condition, with open joints and crumbling bricks.

- 8.2 Paglesham churchyard is also the responsibility of the PCC. The churchyard should be managed in such a way as to maintain a naturalistic and tranquil character appropriate to its rural setting, with low level intervention. The historic character of the graveyard should be respected, including the arrangement of gravestones, planting, and the boundary treatment. However, the scrub has been left to grow up recently, and a considerable amount of clearance is required particularly along the boundary wall and around graves, as well as grass cutting. If left unchecked the

historic character of the churchyard will be eroded, and self-seeded scrub and trees will take hold.

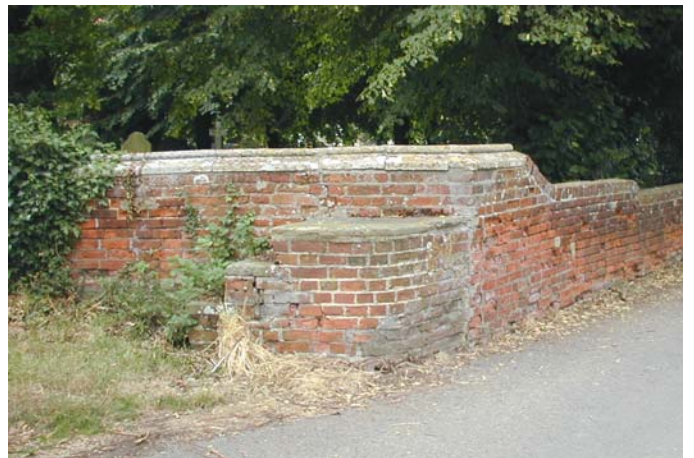
Fig. 28 Mounting block on south west corner of churchyard wall.

7.18 At the south-west corner of the churchyard wall is a red brick mounting block of 18th century date, with stone steps (*Fig. 28*). The churchyard wall here has moulded stone copings. The block and the wall at this corner are Grade II listed, and their condition requires some attention, with encroaching ivy, open joints in the brickwork and split stone.

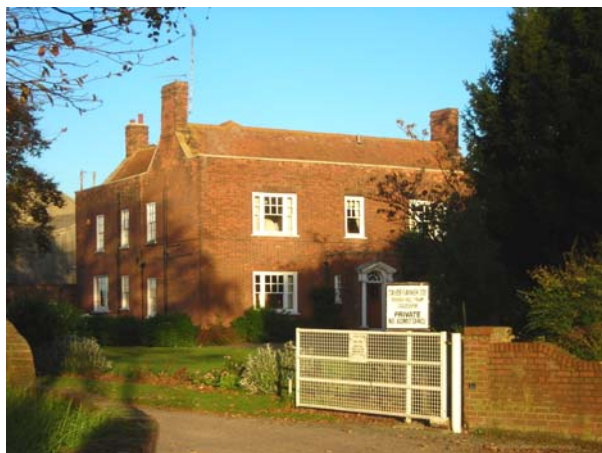
Fig. 29 Church Hall.

7.19 Church Hall is 17th century or earlier in origin, and Grade II listed (*Fig. 29*). It is constructed of characteristic warm red brick with a Georgian façade with parapets

and a fine doorcase with semi-circular fanlight. This is a distinctive high status building in Paglesham having served as the manor house for the church/hall complex. The Hall has formal garden planting to the front with a circular driveway, and the large modern farm buildings that have replaced more historic structures to the rear create an incongruous backdrop. There are attractive views from the churchyard to the hall, framed by trees and planting, emphasising the important historic links between the two buildings. The private road running through the farm leads to the Victorian Church Hall Farm Cottages (*Fig. 30*). These are a semi-detached pair of brick cottages set in large gardens behind the churchyard. They are invisible from the public highway and can no longer be seen from the churchyard, screened by the tall conifer planting where the setting was once more open.

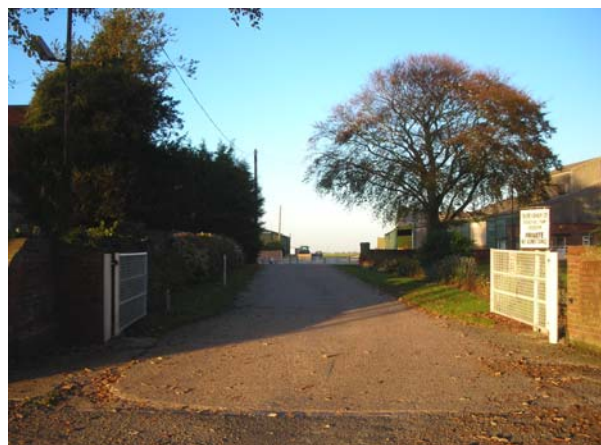
Fig. 30 Private Road, Church Hall Farm.

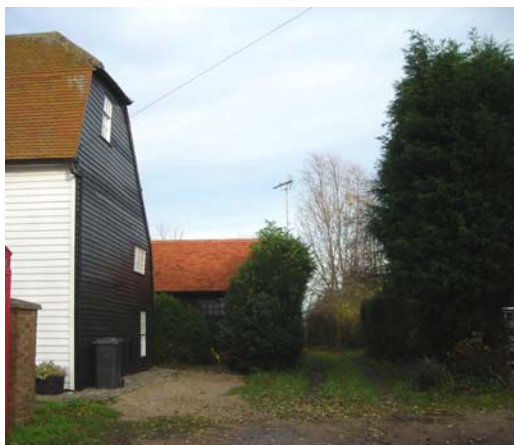
- 7.23 Informal rear access paths as seen adjacent to the Old Post Office and Old Worlds End contribute to the attractive rural character of the conservation area, with grassy tracks and grass verges or gravel surfacing (*Fig. 31*).

Fig. 31 Rear access, the Old Post Office.

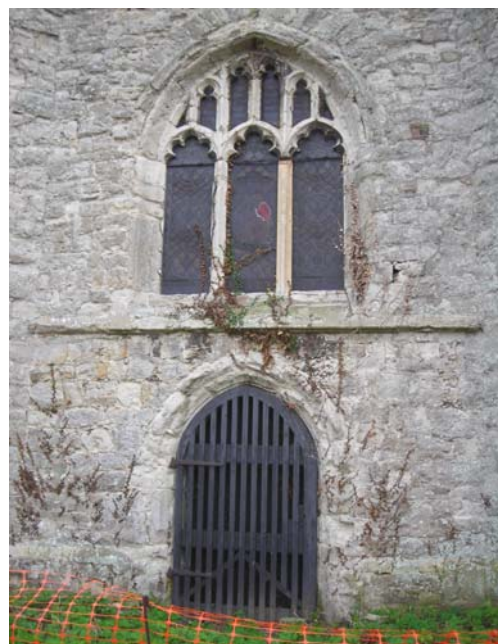
- 7.24 Paglesham church and churchyard are landmarks in the conservation area, and their unspoilt character is undoubtedly part of their charm. However their condition is some cause for concern, as they are taking on a neglected appearance which undermines the attractiveness of the conservation area. Water penetration and ivy growth have damaged the stone work of the church, and as has already been noted this has necessitated the erection of a barrier around the base of the tower where the west window needs conservation (*Fig. 32*). A quinquennial survey carried out in 2006 has identified repairs that should be carried out. In the churchyard many of the gravestones particularly to the north side have become overgrown with self seeded scrub and ivy, and the grass has been left uncut (*Fig. 33*). The churchyard wall is suffering in places from encroaching scrub, and the southern boundary wall is in need of repair where the joints have opened and the soft bricks have weathered (*Fig. 34*). The listed mounting block abutting the wall is also in a poor condition. Whilst a highly managed and manicured approach to the churchyard would not be

Fig. 32 West window and door, currently barriered-off.

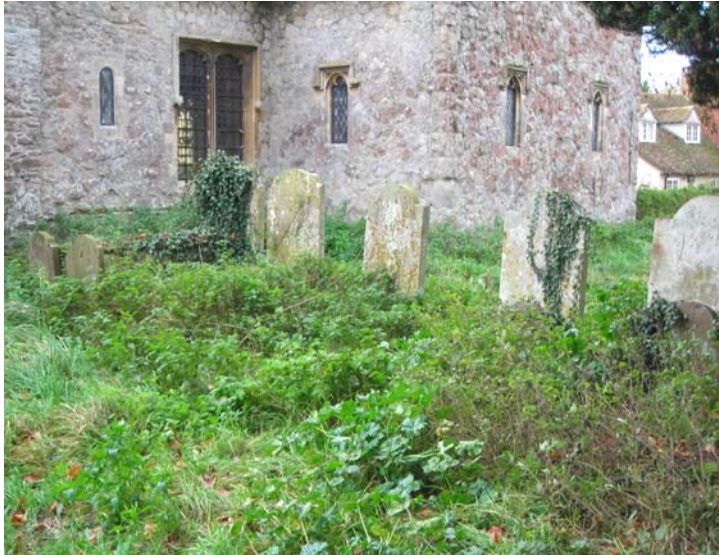
Fig. 33 Overgrown Victorian body tombs, north side of the churchyard.

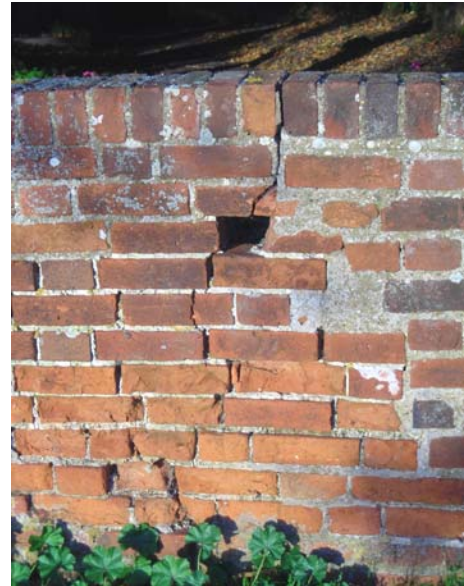
Fig. 34 Cracking, churchyard boundary wall, south side.

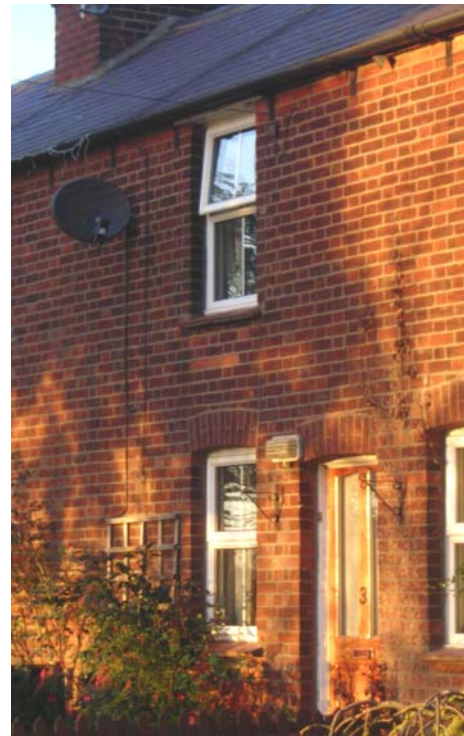
7.25 Many of the buildings in the conservation area are listed, but unlisted buildings also make a significant contribution to the special character of the conservation area, particularly Punch Bowl Cottages and Brick Row. Properties are generally well cared for and contribute to the attractive appearance of the conservation area. In the main, alterations and improvements to properties have been confined to the rear elevations and plots, including rear extensions and garages, which do not impinge on the character of the conservation area. However unlisted properties have had some alterations carried out as part of permitted development, including replacement windows. There have also been some unauthorised alterations notably the installation of satellite dishes on the front elevations of Brick Row, which detract from the special qualities and appearance of the streetscape (*Fig. 35*). Changes of this kind

Fig. 35 Replacement UPVC windows and satellite dish, Brick Row.

constitute a threat to the conservation area that can gradually erode its character.

- 8.3 Unsympathetic alterations can threaten the special character of conservation areas. Unauthorised alterations to listed buildings can be dealt with via enforcement procedures, and many of the buildings that make a positive contribution to the special character of Church End are already listed. It is also possible to increase planning controls over certain alterations carried out as permitted development to unlisted properties, including window replacement and hard landscaping of driveways, by introducing Article 4(2) Directions. In such a small community this would be a rather heavy-handed approach. However owners should be encouraged to reinstate traditional features and avoid further unsympathetic alterations wherever possible in order to preserve and enhance the attractive appearance and special character of their environment.

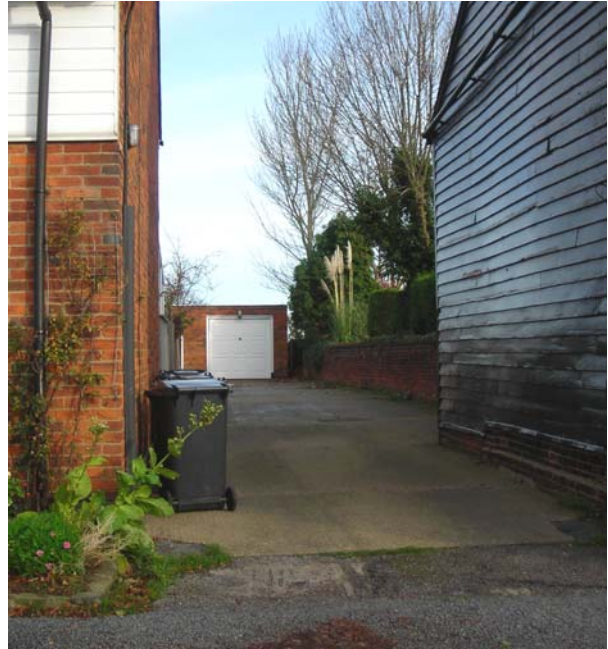
Fig. 36 Rear view, Punch Bowl Cottages.

- 7.26 Generally views through to rear areas are attractive and informal, often contributing to the character of the conservation area. However the view to the rear of Punch Bowl Cottages is less successful, with a hard landscaped driveway and poorly designed garage (*Fig. 36*). Further alterations of this kind to rear access areas would undermine the special character of the conservation area.

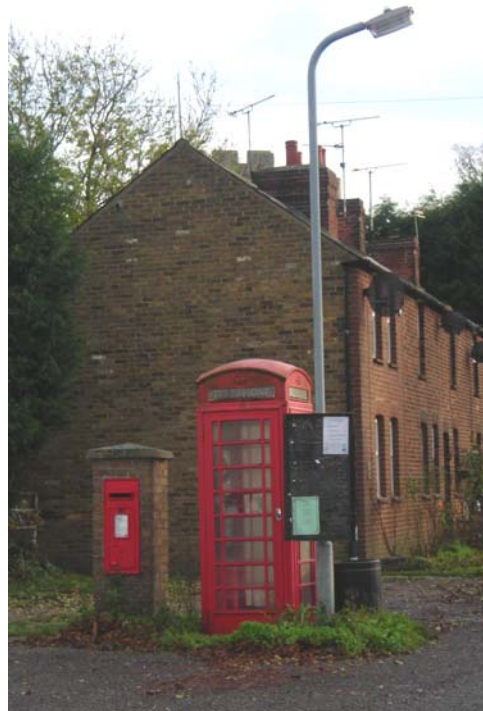
Fig.38 Street furniture.

Some maintenance is required – one of the lamp standards is leaning at a jaunty angle. The group of street furniture outside the Old Post Office including the telephone kiosk and the post box occupies a prominent position in the street scene and is rather untidy. The Highways division could contribute to enhancement and landscaping of this area, and BT should carry out some maintenance of the listed telephone kiosk (*Fig. 38*). There is a scruffy noticeboard which the parish council should replace with something sympathetically designed for the rural context. The undergrounding of overhead wires would also enhance the street scene.
