## BATTLESBRIDGE

# Report on flooding issues for the Flood Forum following a site visit on 16/6/2021.

Jeff Stacey Emergency Planning Business Continuity Officer Rochford District Council

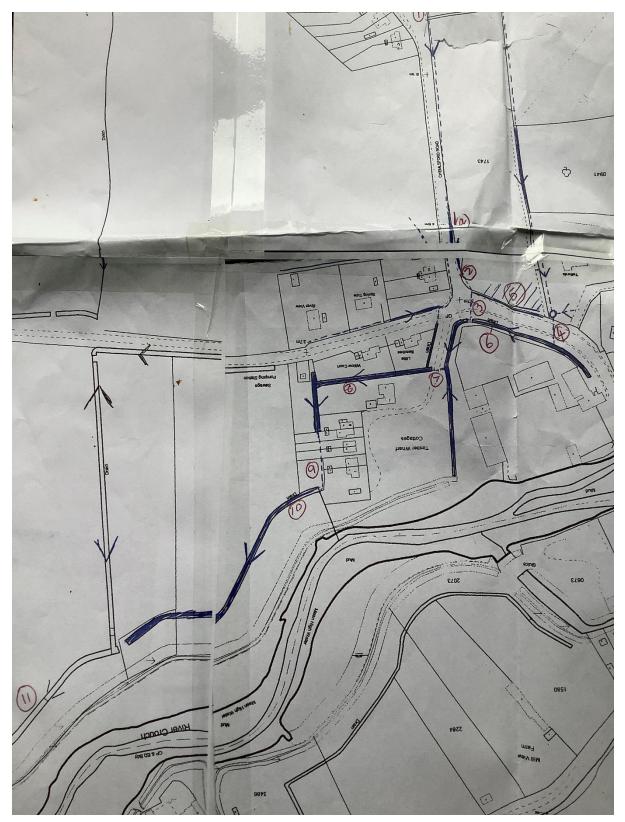
### Flood Advisory Group Battlesbridge Update Report 1

SULS BRITILES BRIDGE KEY TO MAP OPEN DITCHS . PIPED DRAINS 0 OPEN GULLEYS. DIRECTION OF FLOW PAPE RUNNING UNDER RUNINS GOOSE COTTAGES BROKEN AND BLOCKED, CONTINUES UNDER CHELTLS FORD ROAD TO GPEN DITCH (a) . 2) ARED BY ECC (50YRS?) BY PERMISSION OF LAND OWNER TO HEADWALL (CANNOT FIND OUTLET) BLOCKED GULLEY UNDER ROAD- BUTLET BELOW LEVEL OF DITCH (6) (4) SILTED BRICK ARCH GULLEY UNDER ROAD BELOW LEVEL OF DITCH (6) 5 FIELD FLOODED EVERY WINTER BECAUSE GULLEYS AND DITCH SILTED AND BLOCKED, 6) DITCH SILTED BECAUSE GULLEY UNDER TIMBERWHART IS POSSIBLY TOO HIGH ?? . 3 DITCH SILTED WITH OVERGROWN VEGETATION . APE UNDER GARDENS SILTING WATER BACKING OF CAUSING SILTING AT (2) & AND FLOODING GARDON AT NO. 1 TI TBERWHARF FLOW INTERUPTED AT GOAT FARM CAUSING ABOUE BORROW DITCH WAS PIPED SO RESTRICTING FLOW. Ingionally there was an open wile borrow ditch aining the area aroud to the culvert rear Barn in SE corner of marsh. SILTATION OF OUT FALLINTO MAIN RIVER

In the absence of detailed information, this area was removed from the Flood Forum agenda. Since then, I have been in contact with a local farmer with details of the flooding problems and he has provided a diagram of the drainage systems associated with Chelmsford Road and Beeches Road junction (attached to this report). I also gained further information from meeting with the resident of 1 Timber Wharf Cottages.
