GREAT WAKERING

Conservation Area Appraisal and Management Plan

This document was produced by Essex County Council for
Rochford District Council.

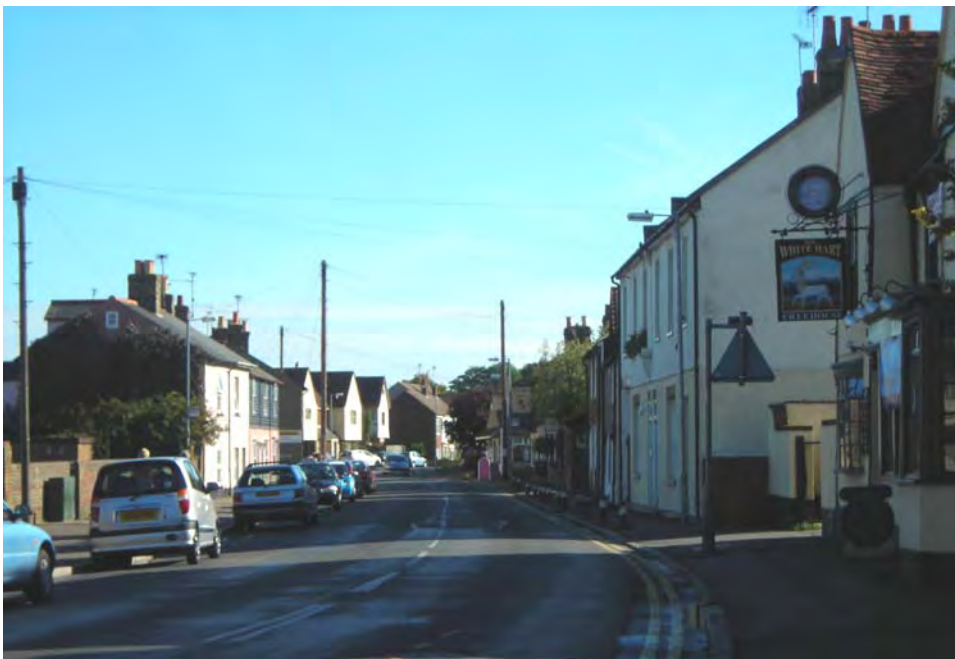
- 7.1 The conservation area is generally continuously built up along the High Street creating a sense of enclosure which is occasionally diminished by late 20th century development (*Fig. 6*). At the east end the street is visually at its most narrow and enclosed with older properties built up against the street edge creating an attractive approach to the church with a strong sense of history (*Figs 7,8*). The High Street comprises a mixture of shops, pubs, houses and community buildings which, with the exception of some more recent developments, mostly front directly onto the street. Occasional roads and narrow tracks, some unmade, head off to the north and south leading to further residential developments, with other openings in the building line leading to back areas and car parks. Until reaching the churchyard, few green spaces or trees provide relief from the built-up street and there are no opportunities to view out to the surrounding landscape. Despite Pevsner's observation that the street 'just avoids being absolutely straight'¹⁰, the gentle curves soften the streetscape, and are sufficient to create changing vistas with movement along the road. Rows and terraces hug the street edge creating serial vision in long views. The ancient church is a landmark building that terminates the view at the eastern end.

Fig. 6. High Street looking east, with over-dominant gables of late 20th century and 21st century development interrupting the grain of the street.

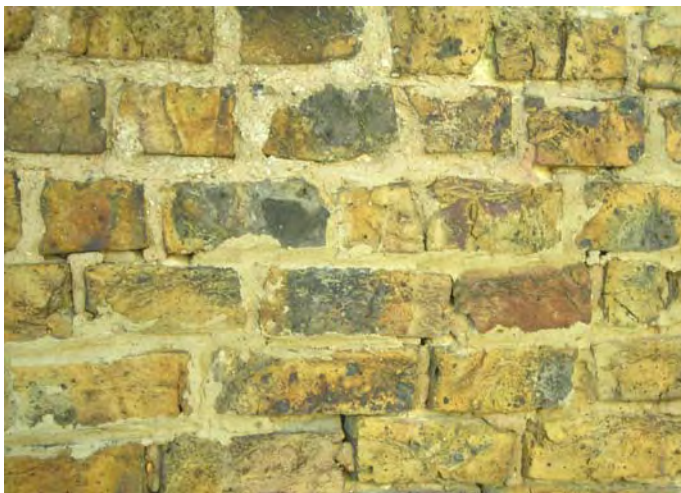
Fig. 19 Yellow brick.

- 7.11 Yellow stock brick was commonly used from the 19th century onwards. This was a cheap building material, but the inclusion of ash and other waste products in the fabric creates an attractive vari-coloured appearance (*Fig. 19*). Occasionally local soft red brick is also seen. Brick was used to reface older timber framed buildings. Brick walls are often rendered or painted, and finished in a light colour. In the past exposed brick would have been more evident in the built environment. Chimney stacks are generally left unrendered. Brick is sometimes used decoratively on Victorian gothic buildings such as the old school and the polychrome United Reformed chapel. Recent developments have introduced a wide variety of modern brick into the streetscape. These bricks lack the character and texture of the historic materials.

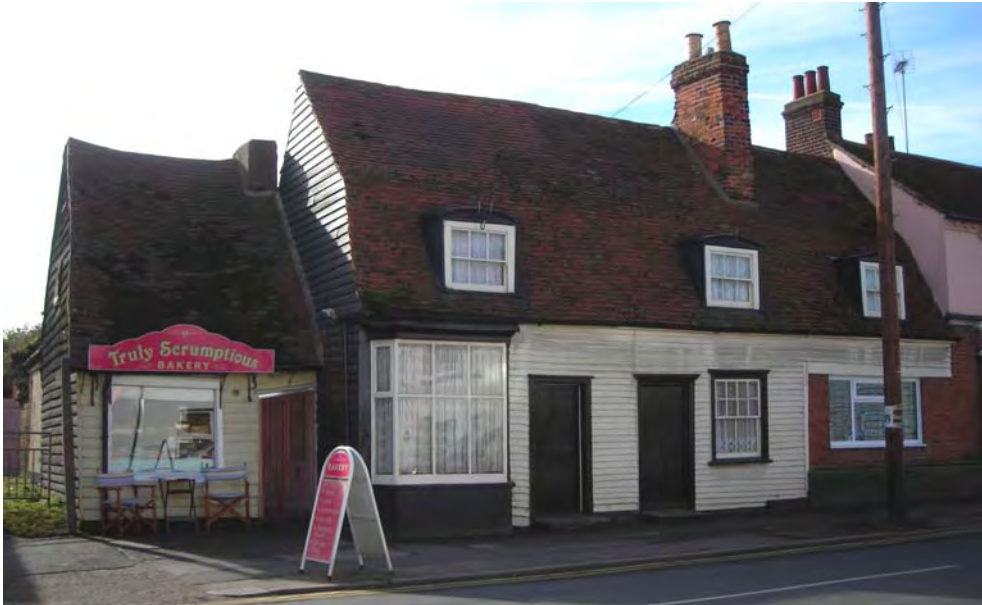
Fig. 33 Nos 63, 65 and 67 High Street.

- 7.19 **Nos. 63, 65 and 67 High Street** are a row of 18th or 19th century cottages that make an attractive vernacular contribution to the streetscape (*Fig. 33*). These cottages are timber framed and weatherboarded, with the exception of the ground floor of no. 67 which is partially of red brick and now forms part of the adjacent Red Lion pub. No. 65 has a bay shop window with a moulded surround, a reminder of its former commercial use. The cottages retain two traditional boarded doors. They have clay tiled gambrel roofs, with three small segmental head dormers. Their weatherboarded left side elevations contribute to the street scene, made visible by the adjacent gap in the building line where a footpath passes through. No. 63 is now used a bakery. The cottages are Grade II listed.

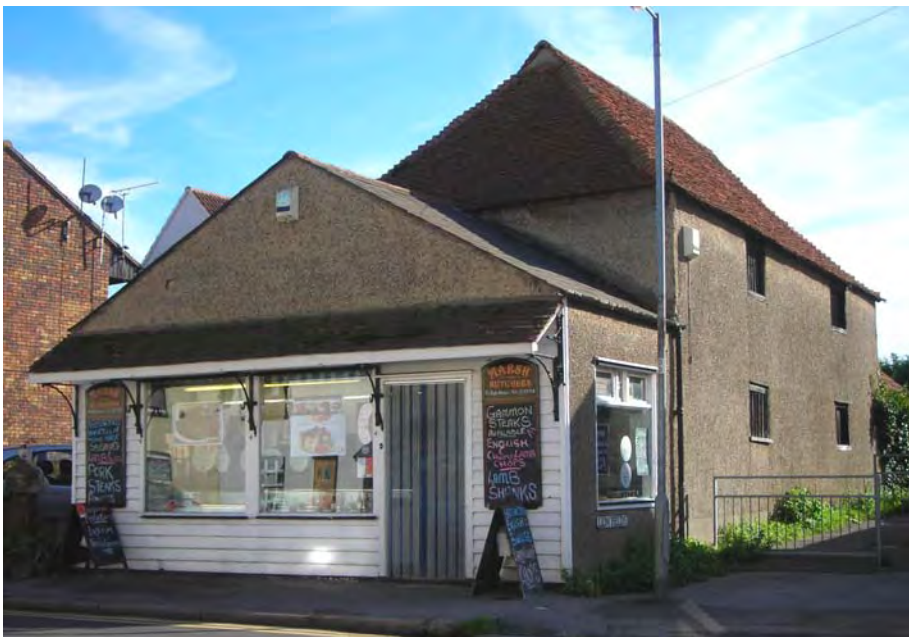
Fig. 35 No. 61 High Street.

- 7.21 Beyond the footpath is one of the most characterful of buildings on the High Street, **no. 61**, a butcher's shop and store which remains in use today (*Fig. 35*). It is of early 17th century and 19th century construction. The long timber framed rear range is pebbledashed, probably over weatherboarding, with wooden mullioned windows, and is a significant feature in the streetscape visible from the adjoining yard and from the footpath running along the side. The front range comprises the single storey butcher's shop which is weatherboarded, and has a clay tiled canopy supported on wrought iron brackets with meat hooks. The shop is Grade II listed.

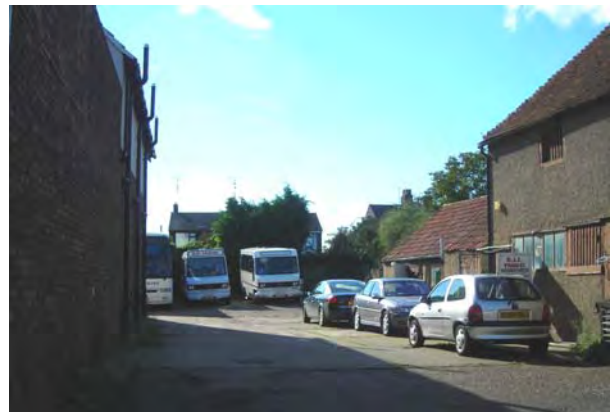
- 7.22 The yard adjacent to the butcher's shop creates an untidy and unattractive setting to the listed building, and an unappealing view from the street (*Fig. 36*). Whilst over-management of this space would not be a fitting for the setting of this humble utilitarian building, some improvement such as resurfacing and modest landscaping is desirable.

Fig. 36 The yard adjacent to 61 High St.

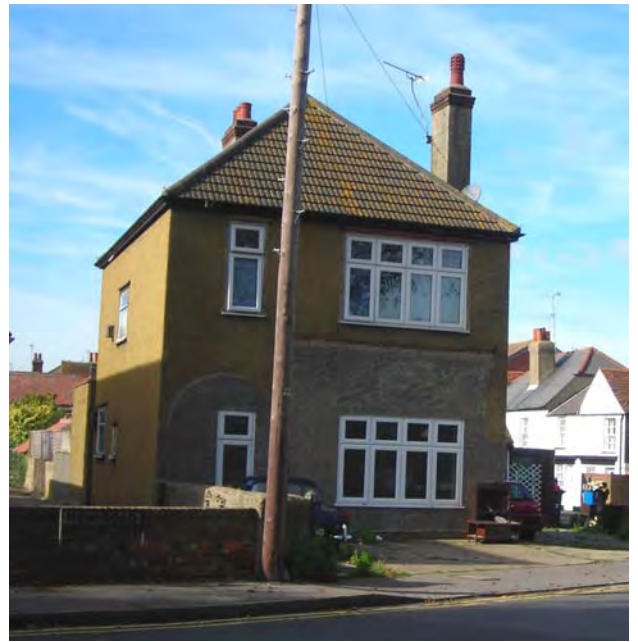
Fig. 45 No.1 High Street, New Road elevation.

7.29 Opposite the church, **1 High Street** occupies an important position on the road junction, and was also formerly on the Local List (*Fig. 45*). This pebbledashed early 20th century detached villa currently has a poor appearance which detracts from the street scene. The property has patchy pebbledash render and poor replacement plastic windows, and an untidy hard landscaped frontage opening onto the footway in New Road, although a brick wall provides a boundary to the High Street side. Improvements to the appearance of the building and plot could make a significant contribution to the enhancement of the conservation area at this prominent point.

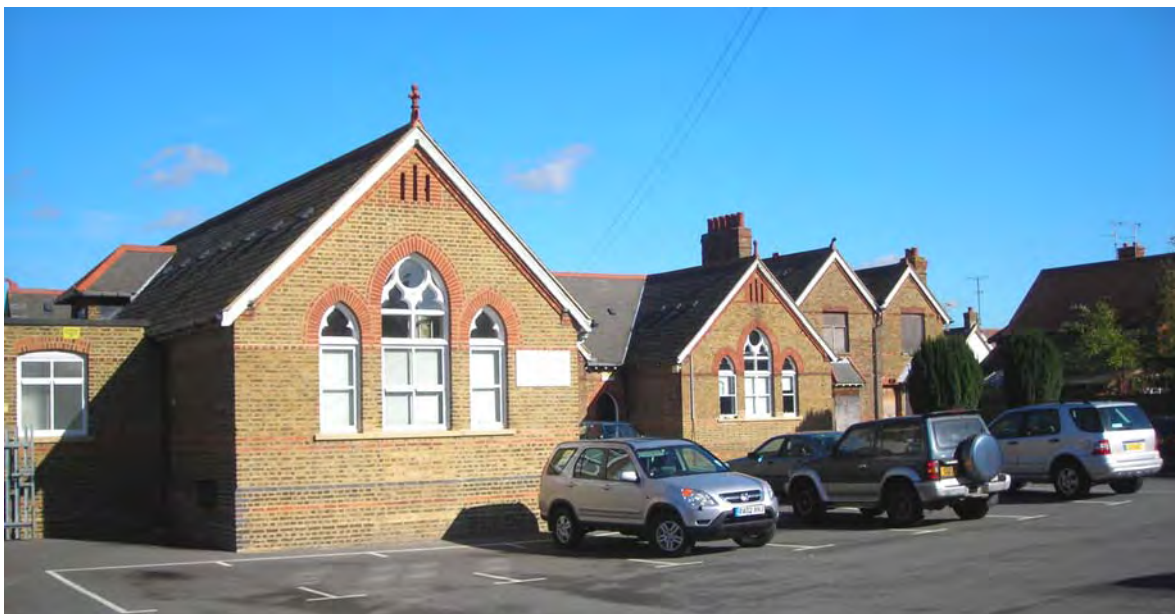
Fig. 46 Community Centre, former school.

7.30 At its west boundary, the conservation is marked by the **old school**, built in a Victorian gothic style in 1876, and now a well used community centre (*Fig. 46*). The building is generally in good condition, retaining its original boundary wall to the street of yellow stock brick with red brick string courses. However part of the building is now disused and boarded up. The school was formerly on the Local List.

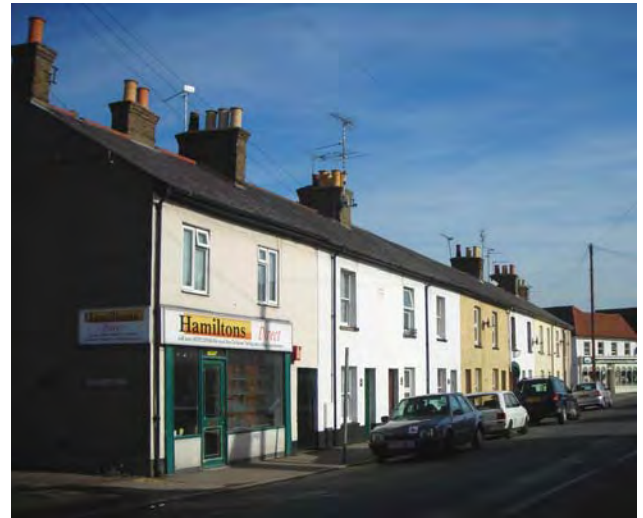
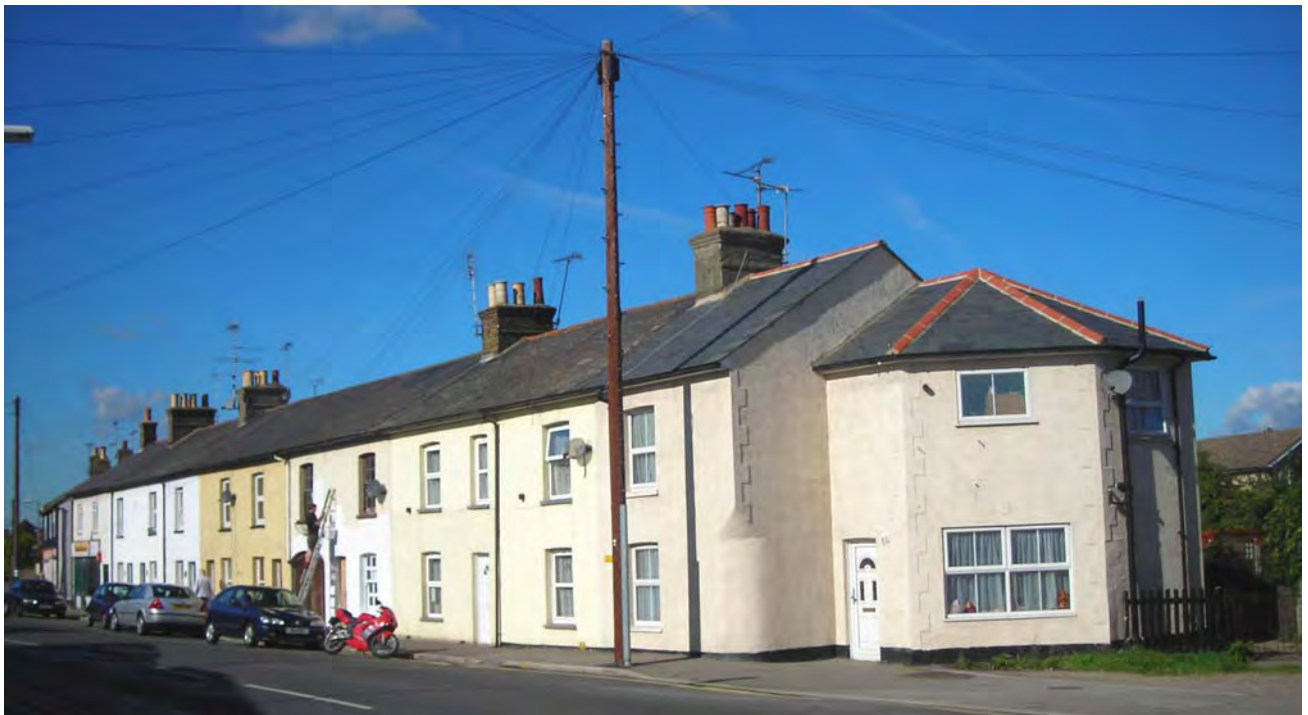
7.33 **Nos 66-82 High Street** are a continuous row of late Victorian painted or rendered brick cottages and shops. They are a prominent feature of the High Street and an important element in its special character, built up to the pavement edge between North Street and Chapel Lane (*Figs. 50,51*). Incorporating Prospect Cottages of 1878, this row was formerly on the Local List. These cottages have been greatly abused by unsympathetic alteration, particularly replacement plastic windows and doors. The shop at No. 82 appears to be unused at present.

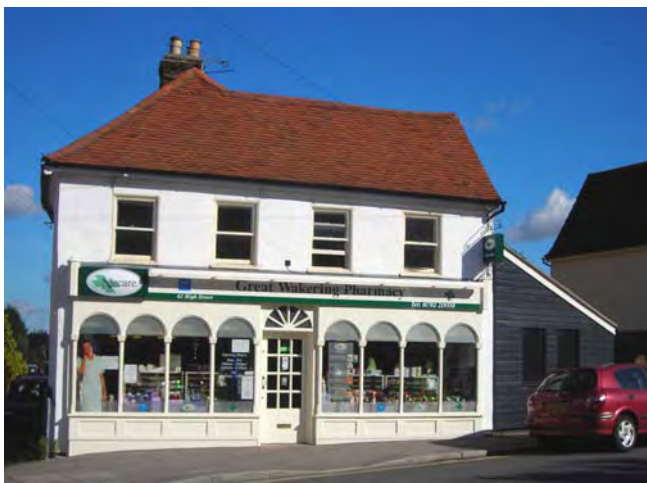
Fig.55 No. 62 High Street and Roundabout.

- 7.36 Occupying an important corner site, **62 High Street** and the adjoining property known as **Roundabout** are Grade II listed and dominate the junction between the High Street and Chapel Lane, given prominence in the streetscape by the curve of the road (*Fig. 55*). The main building is early 18th century or possibly earlier with later alterations and additions, and is timber framed and rendered, with a clay tiled double range roof. The High Street elevation has a traditionally-styled 20th century ground floor shop front with round headed windows, added around 1983, but with a plastic fascia. The Chapel Lane elevation contrasts with the High Street appearance and is more residential in character, with moulded eaves cornice, black painted joinery and a 19th century door case with a moulded canopy and fluted surround (*Fig. 56*). There is a sympathetically restored rear weatherboarded range with catslide dormers. Roundabout is a heavily restored mono-pitched structure to the right of no. 62, with a door to the side. The current appearance with weatherboard cladding dates primarily from restoration work carried out around 1986.

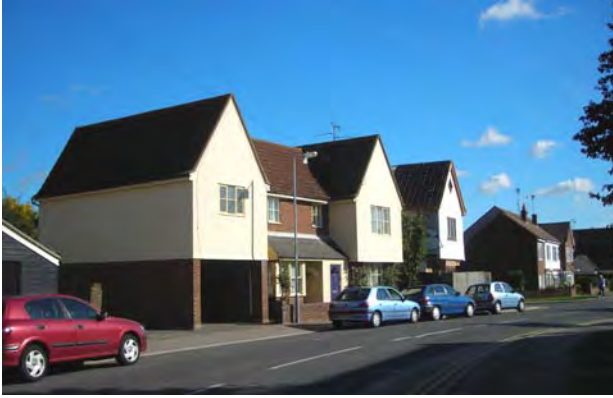
Fig. 57 No. 60 High Street

- 7.37 East of this the High Street is again dominated by late 20th and 21st century development of varying quality representing infill and replacement. **No. 60** is a substantial detached property constructed in the 1980s in a traditional style with two cross-wing ranges with gables to the street. It is rather large in scale and lacks attention to local details (for example with horizontally proportioned windows), but makes good varied use of materials (*Fig. 57*). Occupying an important position on the corner of Whitehall Road a new detached property is under construction. This property makes a rather catholic use of traditional materials and details, but its gabled front elevation creates an attractive shadowed building line with those of its neighbour along the curve of the street, and the whimsical dragon-hugged chimney pot is a nice detail (*Fig. 58*). It is however a large property for the size of the plot, and the close boarded boundary fence only draws attention to this. A low boundary wall or more open treatment would be more attractive and appropriate to the conservation area, and give the building more breathing space. Beyond the junction with Whitehall Road **nos 36-42 High Street** are a row of late 20th century houses. These are a modern interpretation of the traditional building form, constructed of modern materials with a varied brick and render front elevation, but with plastic windows of strong horizontal emphasis.

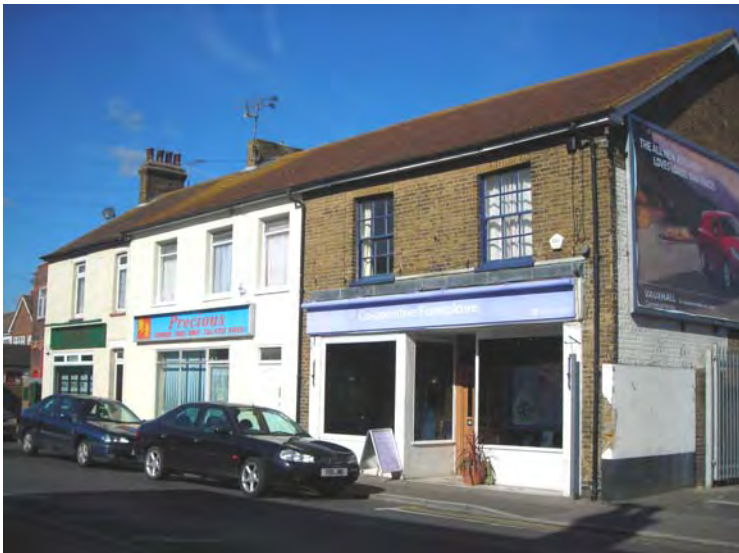
Fig. 60 Nos 28-32 High Street.

7.39 **Nos 28 to 32** are a row of Edwardian stock brick shops, one marked 'Coronation Villa, 1902' (Fig. 60). No. 28 has a traditional form of shop front with a recessed doorway and old detailing, including canopy brackets and moulded monogrammed panels, now painted over, on the stall risers. It has traditional small paned sash windows to the first floor, with fine glazing bars, but otherwise the row suffers from unsympathetic replacement windows and doors, including poor shop windows.

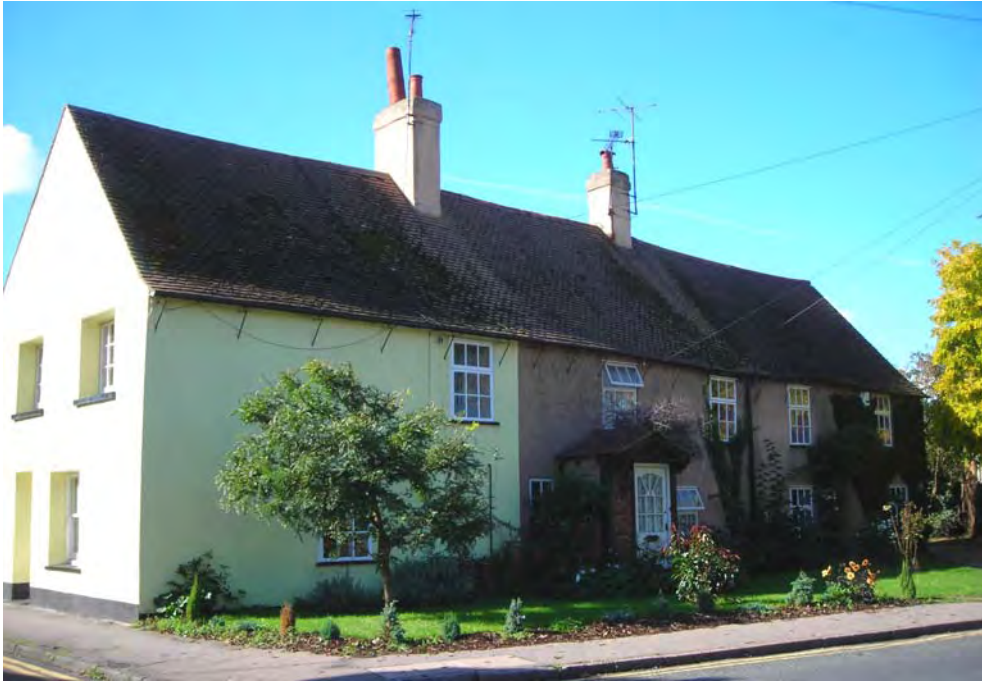
Fig. 72 Nos 4-8 New Road.

7.47 **Nos 4-8 New Road** are an attractive row of cottages set at an oblique angle to the road with attractive open front gardens (*Fig. 72*). They are of uncertain date, possibly 18th century. Buildings are shown on this site on the Chapman and André map of Essex of 1777 standing isolated on the edge of a large open plot at a time when the village was more rural in character. They have suffered from replacement plastic windows and other unsympathetic alterations, but they are still a picturesque group of great value to the street scene.

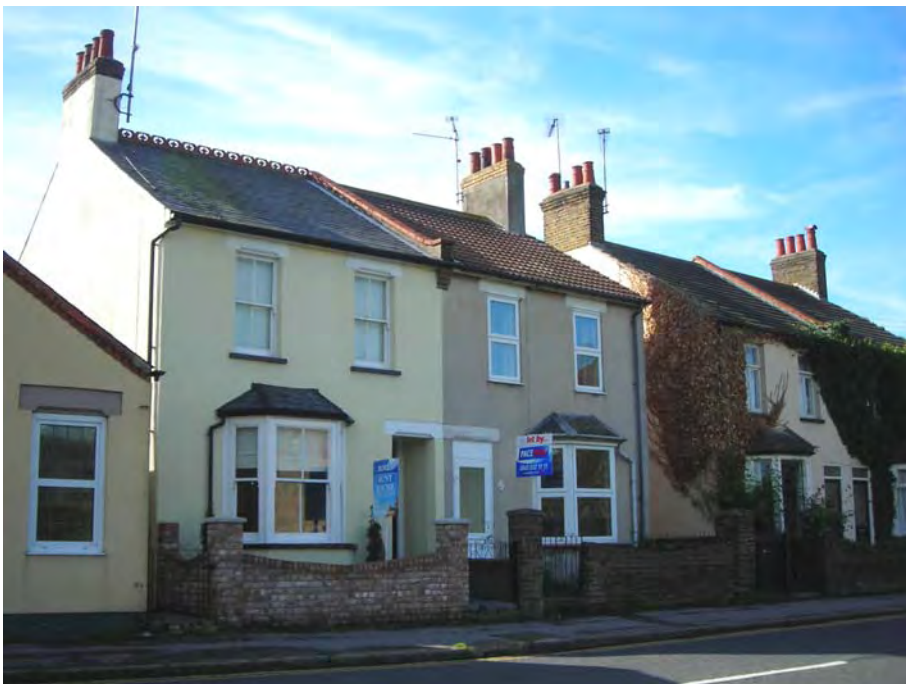
Fig. 73 Nos 10-16 New Road (16 to the left).

- 7.48 **Nos 10-16 New Road** are two pairs of semi-detached Edwardian cottages that are characteristic of suburban development in these peripheral roads (*Fig. 73*). No. 16 is a fine example of a well preserved cottage, with original sash windows, canted bay window and slate roof, recessed door and decorative ridge tiles. The other cottages have been much altered, including replacement windows and flush doors, although some original brick front boundary walls have survived. The yellow stock brick flanking wall to the rear garden of no.10 extends along St Johns Road, and is a good survival of a traditional local boundary.

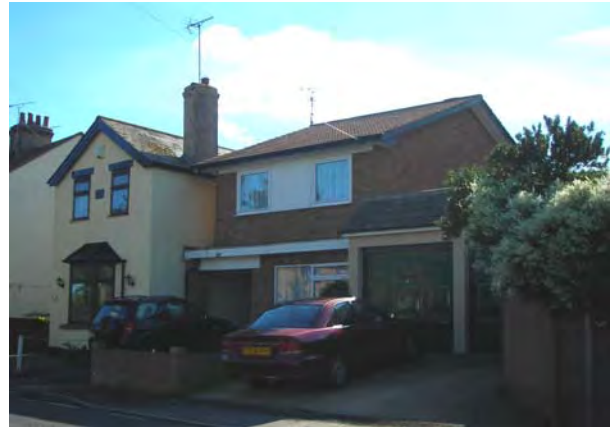
Fig. 74 Alexandra Villa and 16a New Rd.

street scene. **No.18 New Road, Alexandra Villa** dated 1897, is a small detached house that is more characteristic of the suburban turn of the century development at the east of the conservation area, and is smartly kept but with unsympathetic replacement windows (*Fig. 74*).

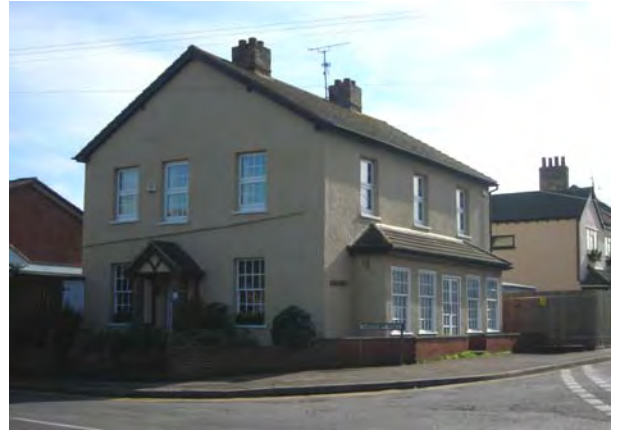
Fig. 76 No.1 Shoebury Road.

7.50 **No.1 Shoebury Road** is a large detached late 19th century property known as Waking House (*Fig. 76*). It occupies a prominent corner position, and has suffered from some unsympathetic alteration including poor replacement windows although there are some sashes to the ground floor. Opposite this at **nos 2-4** is the old bakehouse, Bakery Court, a prominent Victorian terrace with a later single storey pitched roof range to the right occupying an important position on the curve of the road (*Fig. 77*). This was converted to flats in the 1980s, and has again suffered from alterations that have eroded its Victorian character. These include flush mounted

replacement windows and doors, and re-roofing in machine-made interlocking tiles, although the carriage arch has survived providing back access to parking.
